Ms. Marylin Friend  
2020 N. Longview Ave., Brookfield, WI.  
06/01/2017

Scot W. McLean, ASHI  
333 W. Brown Deer Rd. #117, Bayside, WI 53217  
Phone: 414-228-6573  
<http://www.tandcinspection.com>

# Report Index

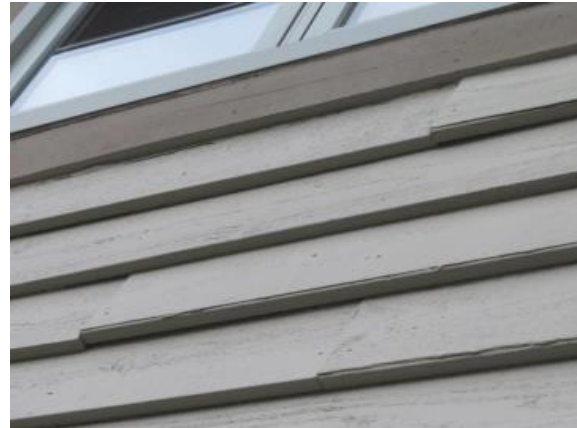
Appears functional, Typical for age,  
**Deterioration: Typical for age. Loose siding, Needs common maintenance/touch up/repairs.**

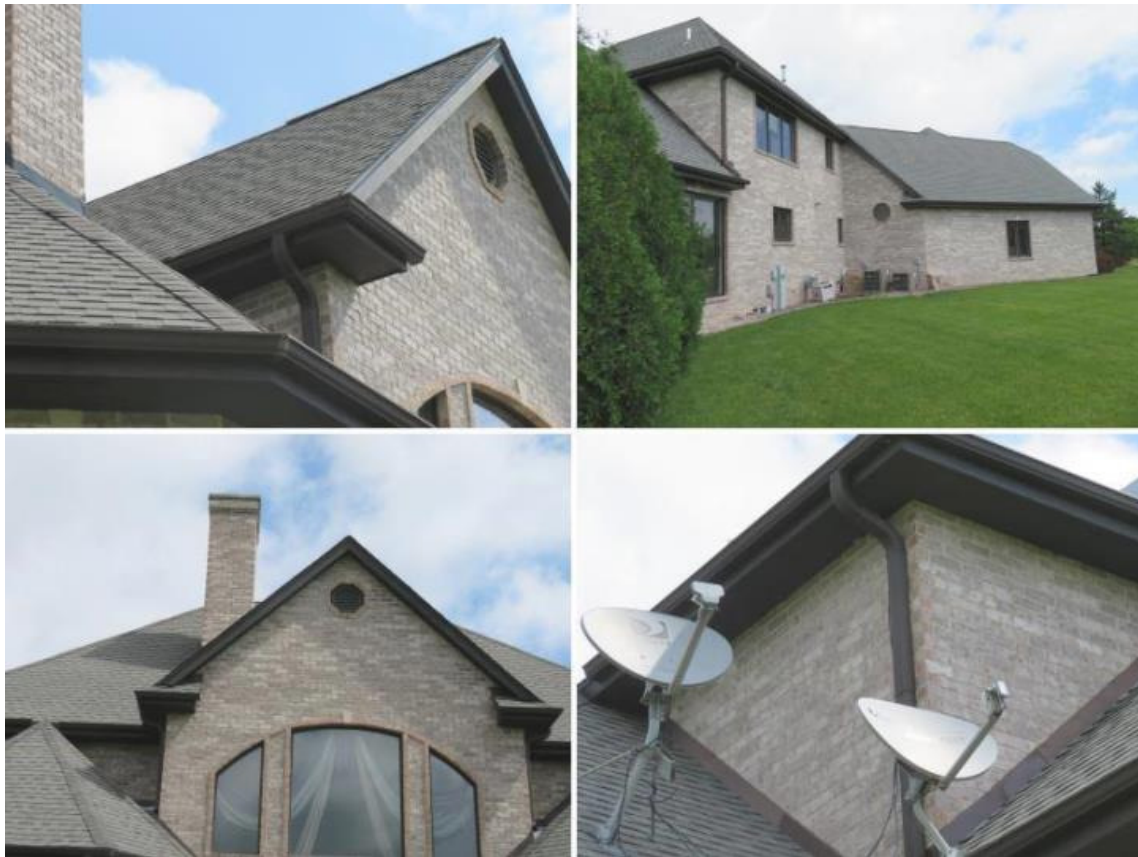
Brick, Appears intact, Appears functional, Typical for age, Monitor/evaluate for common maintenance needs. Seal any gaps/openings.

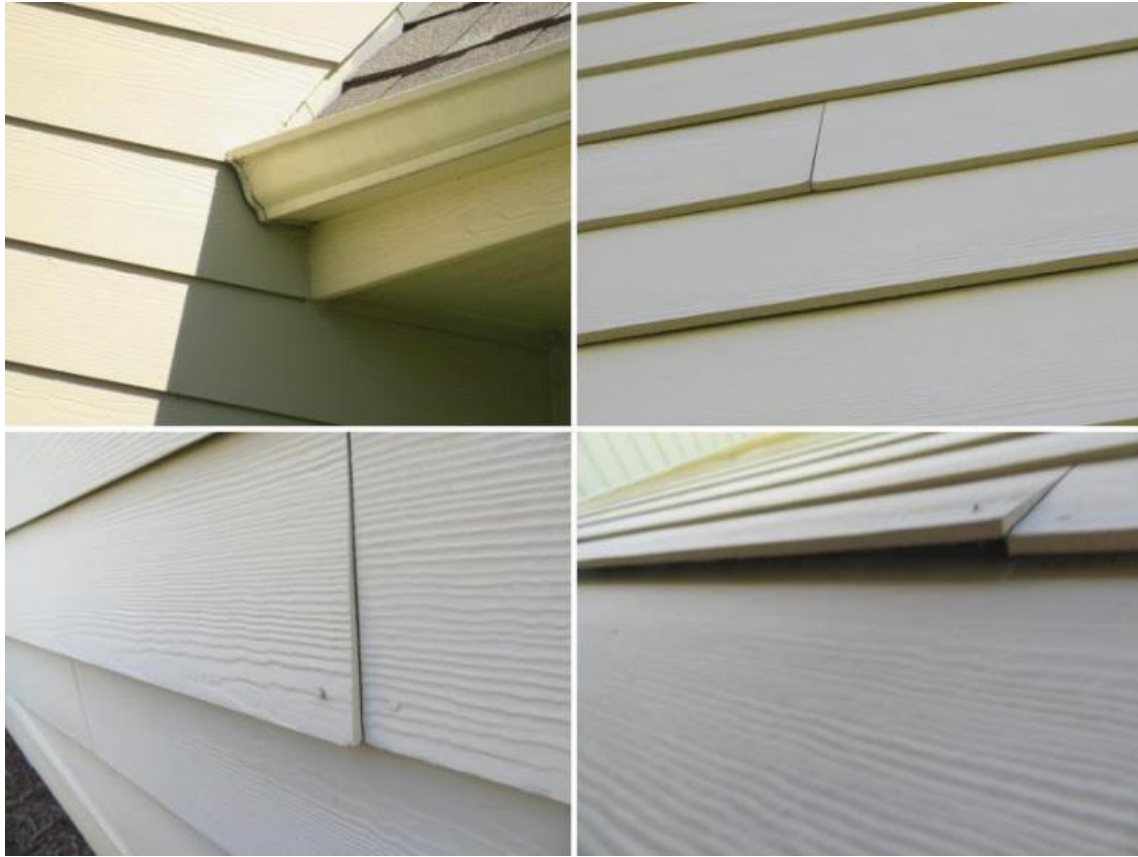
Appears generally intact. Installation; maintenance, and clearances are important to maintain life expectancy and prevent water related concerns and wear. No readily apparent significant deterioration for the age and era of material and installation techniques observed at the inspection. Having a periodic maintenance review can assist in achieving greater longevity of these materials and good function, monitor. **Extensive face nailing, Dropped panels. Splintering noted at edges/ends indicates panels were improperly cut/sealed. Seek further evaluation by a qualified specialist.**

**Evaluate for common maintenance needs now.**

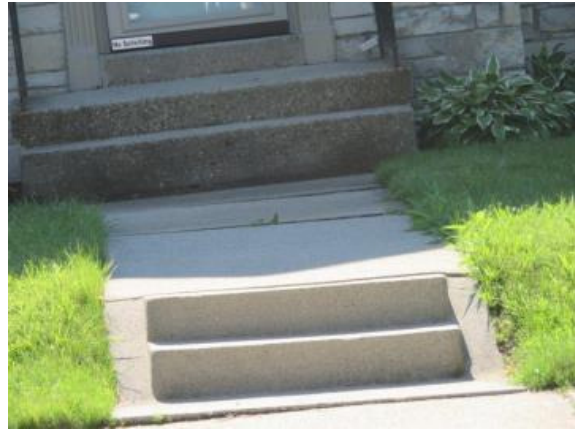
Appears intact, Appears functional, Typical for age. Older/worn, **High step up where walk has settled. Uneven rise/run at steps.**

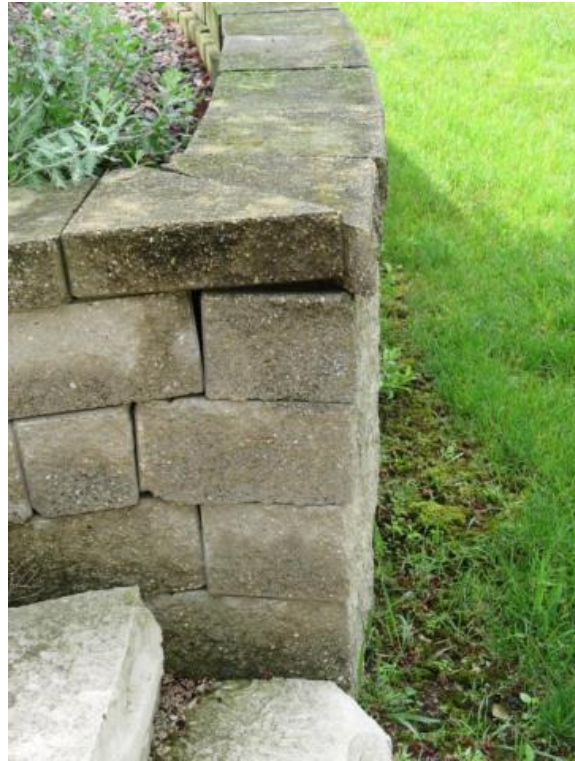
No drainage noted, Bowed, Leaning, Loose stones.

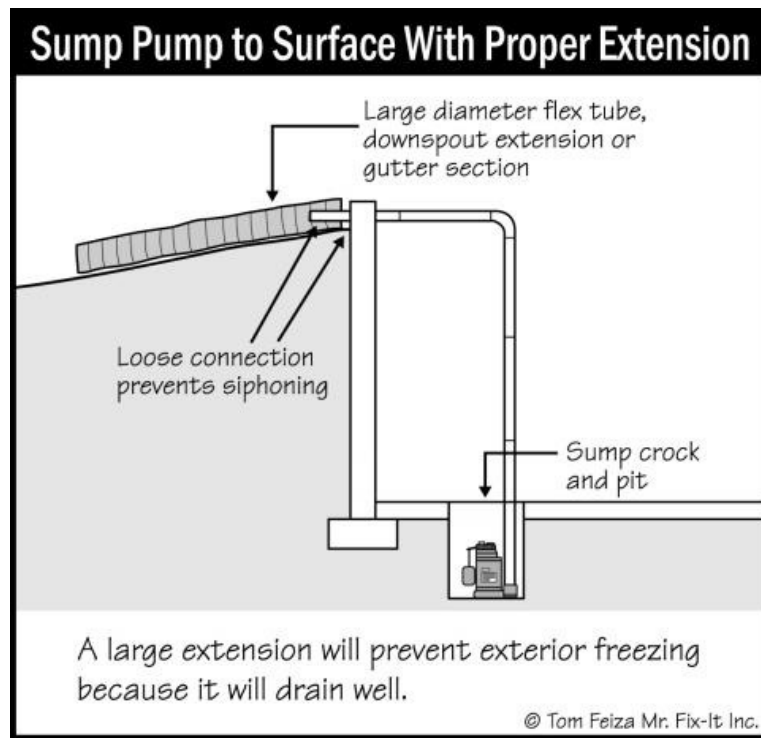
B055

Small diameter sump discharge hose. See note 112 in Reference Addendum.

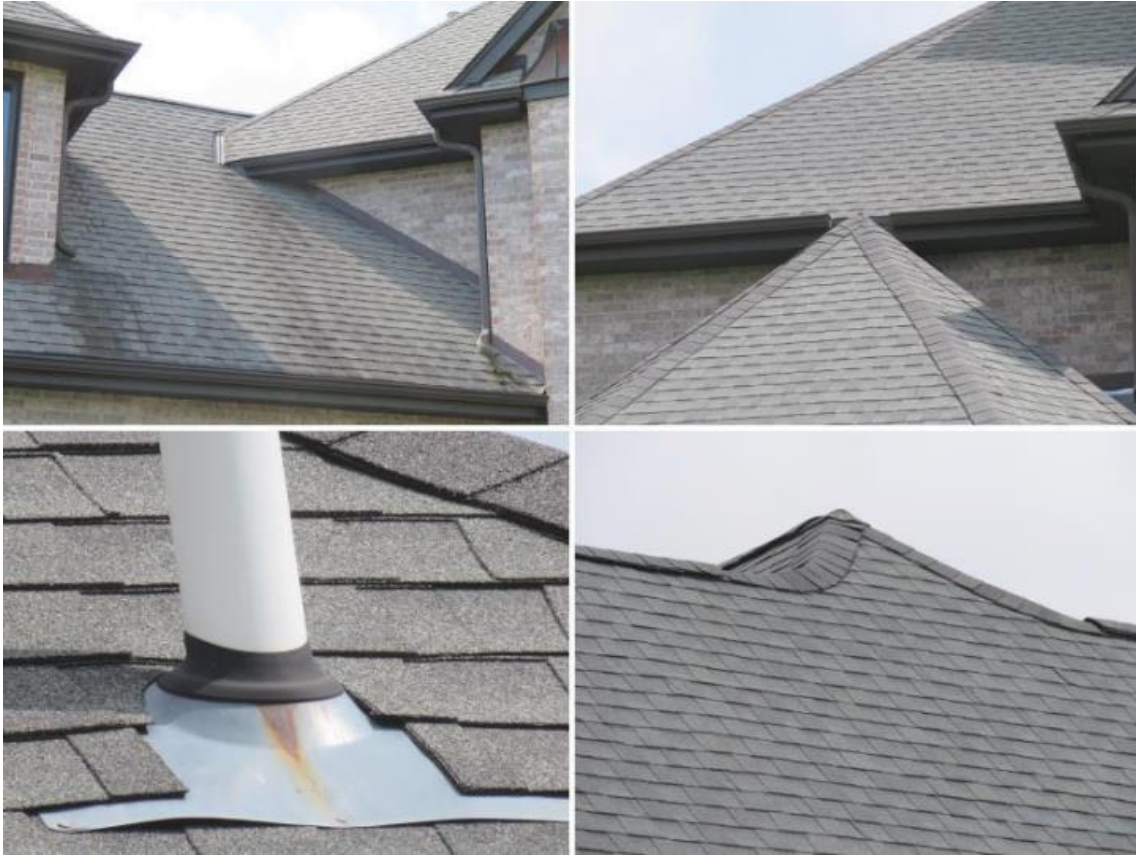
Appears functional, Roof is in good overall condition. No generalized lifting, curling, or advanced wear noted. Beginning signs of wear/aging. Some observations include: Granule loss, Algae present. This discolors the shingles but does not harm the roof structure or shingles.

Annual monitoring/inspection and ongoing routine maintenance are critical to the performance of roofing systems. Inquire with owner/occupant about any history of seepage and repair history.

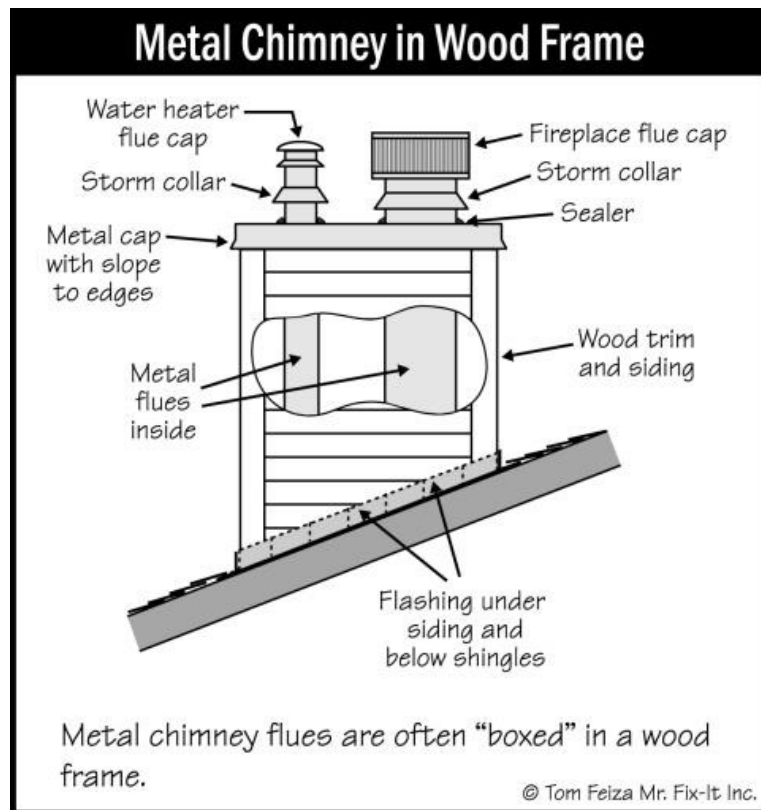
F031

Boxed in chimney flue.  
Top of chimney is not  
observed/evaluated.

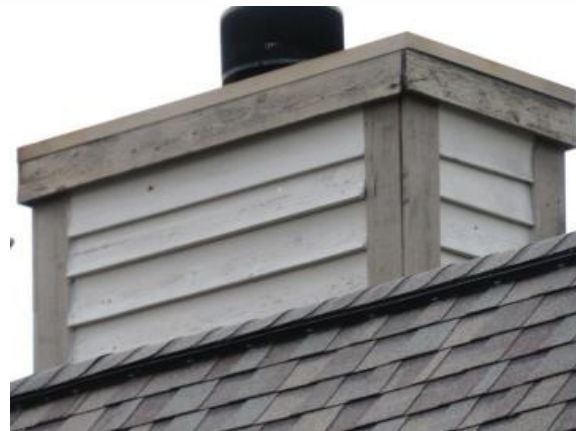
Top of chimney is not observed/evaluated. Corrosion/ rust evident- clean and examine fireplace systems suggested.

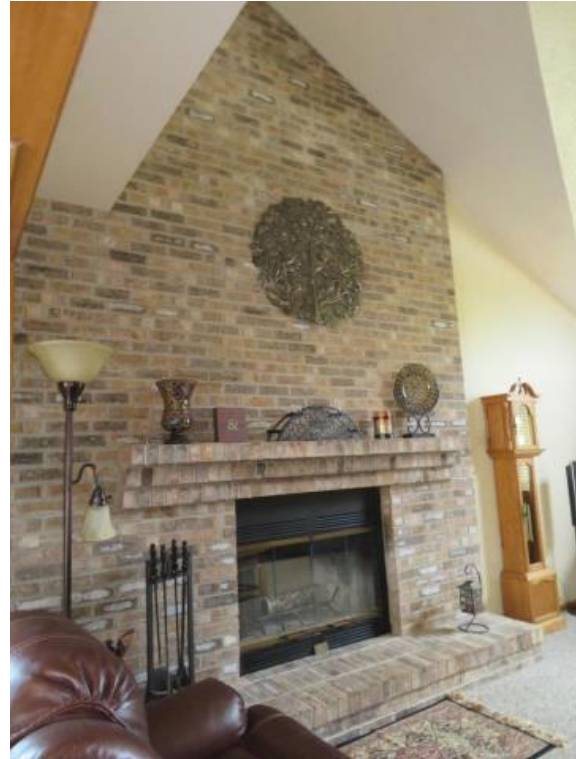
Masonry, Sealed. Natural gas only. 1-No access inside fireplace. 2+ fireplaces present, Appears functional, Damper damaged/stuck/inoperative, Suggest further evaluation of fireplace, chimney(s), and flues by a qualified chimney specialist.

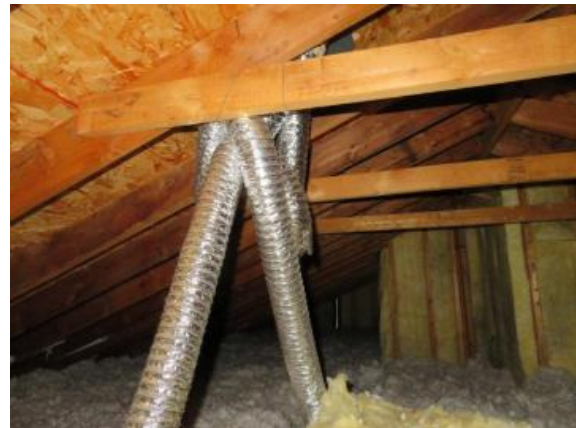
**Disconnected/Fallen/Damaged, Dips/bends observed in exhaust tubing.** *Too many dips/bends in an exhaust run can cause condensation in the tubing and may freeze, damage the tubing, and/or leak. To prevent water stains/damage to finishes, suggest using a metal vent pipe that does not have many bends in it.*

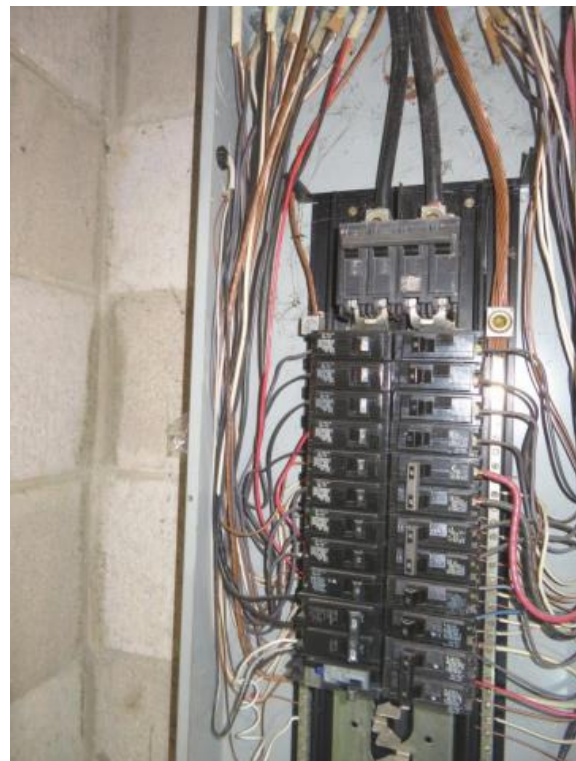
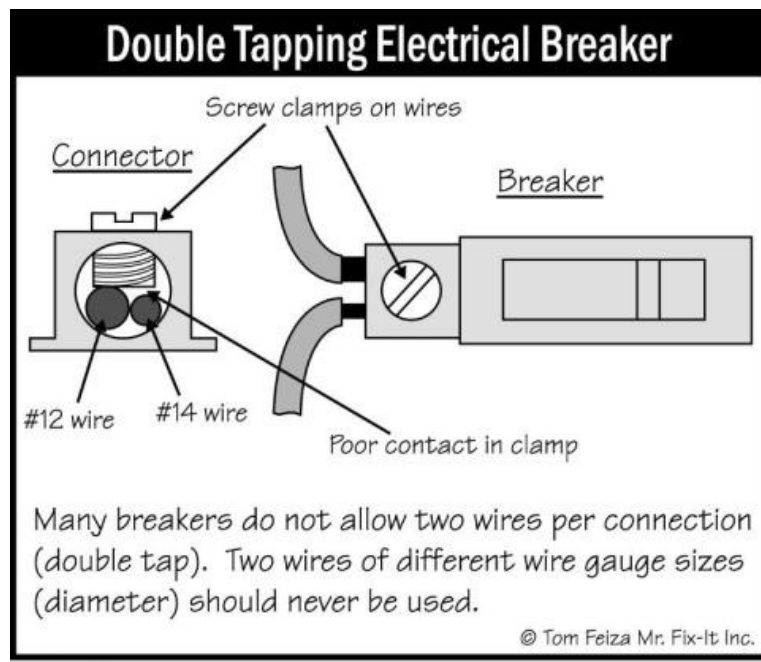
E047

Appears functional, There appears to be more than one wire per breaker/fuse. Consult a licensed electrician for recommendations. Main panel is crowded. There is little to no room for additional circuits. Labeling not complete, Duplex breakers are installed in a slot/panel that appears as not rated for duplex breakers.

Have a licensed electrician evaluate electrical system for good function and safety. Correct as needed. Suggest a complete check of system by a licensed electrician.

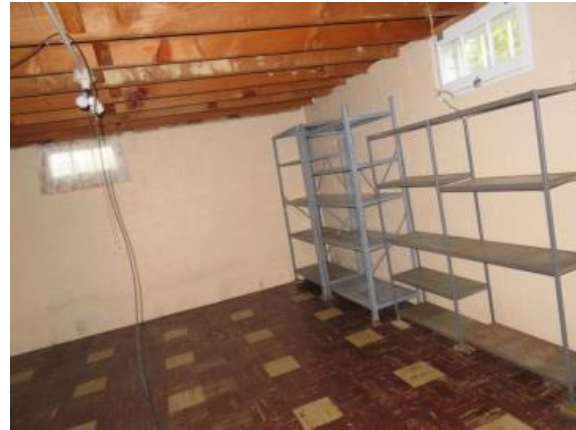
Concrete: Appears intact. Minor concrete fracturing is typical and not indicative of a problem. Water stains at floor fractures. Possible asbestos floor tile. *Determining the presence or absence of asbestos is outside the scope of this inspection. Consult an asbestos abatement specialist for testing and recommendations as needed before disturbing or if damaged.*

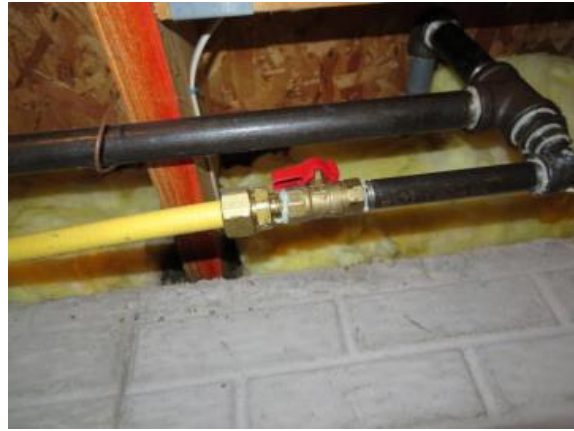
Iron, **Flexible vinyl covered stainless steel (CSST). No bonding. This is a potential hazard. Suggest further evaluation by a licensed electrician.**
