Mr. Buyer
2030 Martin Dr. Milwaukee, WI.
01/21/2022

Scot W. McLean, ASHI
333 W. Brown Deer Rd. #117, Bayside, WI 53217
Phone: 414-228-6573
<http://www.tandcinspection.com>

Inspection Summary

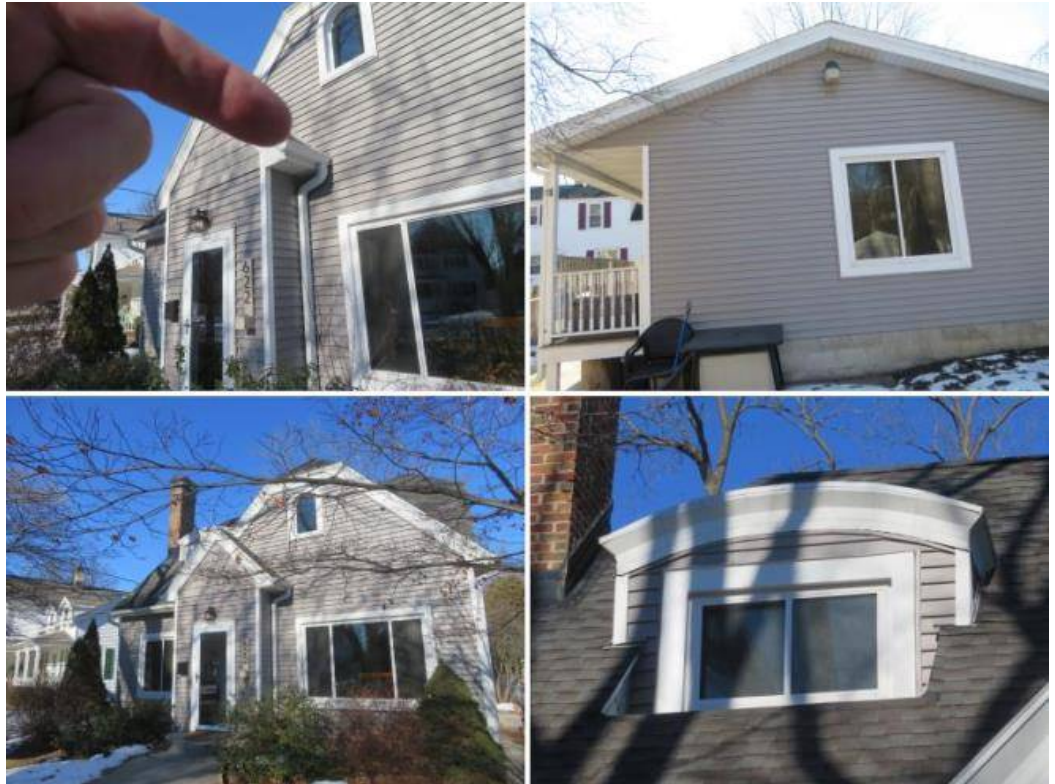
Siding Flashings

Water management system not observable. See 108 in Reference Addendum.

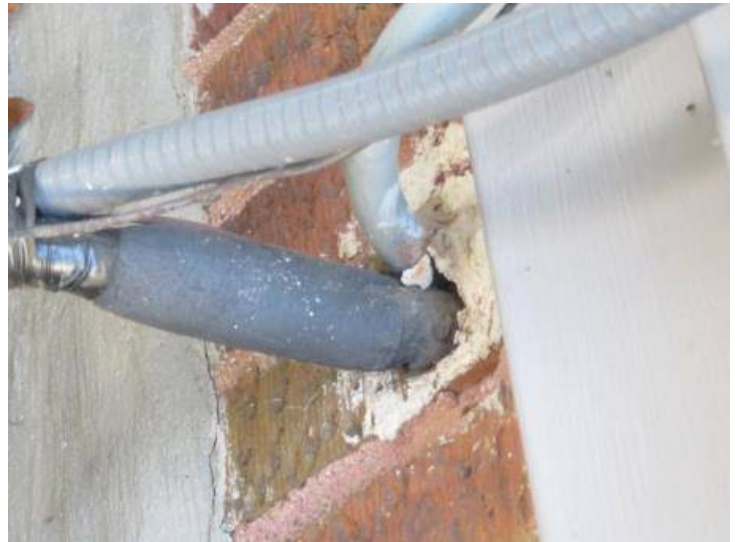
Restricted view of foundation/siding/weepers/drainage planes at exterior due to soil/wood chips/stones/plantings/snow. **Gaps large enough for pests to enter building observed. Seal/patch gaps.**

Mastic/caulk sealing materials are not flashings. Mastic/caulking is temporary and is typically not to be installed or used as a repair in lieu of needed flashings at siding, masonry, windows, doors, roofs, chimneys, etc. See note 107 in the Reference Addendum.

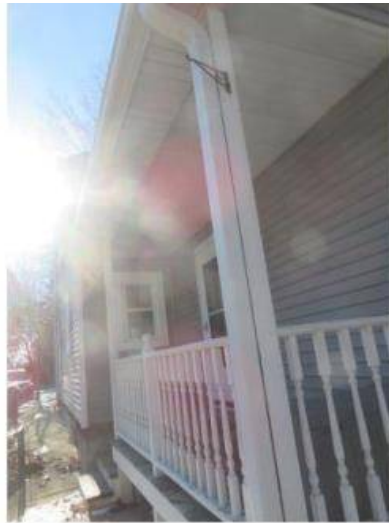
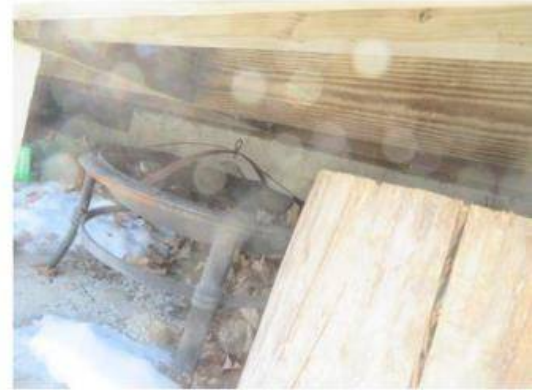
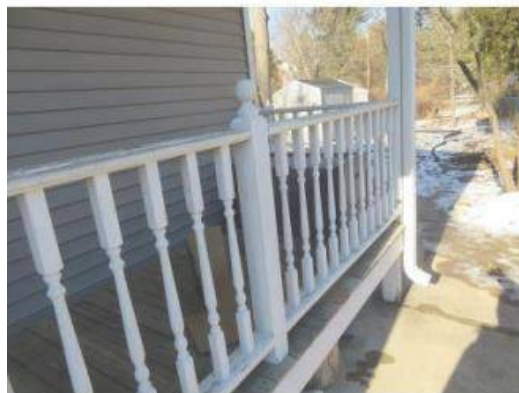
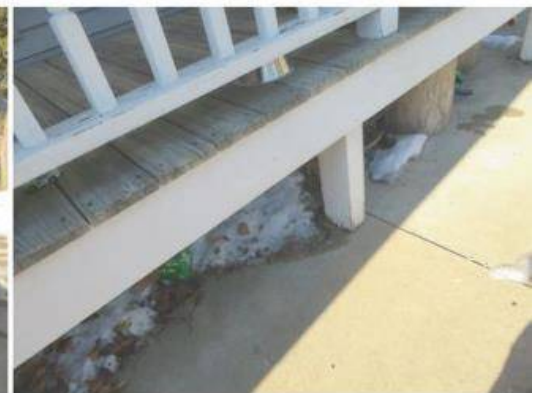
Appears functional, Restricted access/obscured view under deck limits the extent of the inspection. Older/worn, **Some deterioration noted. Needs paint/stain.**

Porch needs maintenance/paint/stain/preservation.

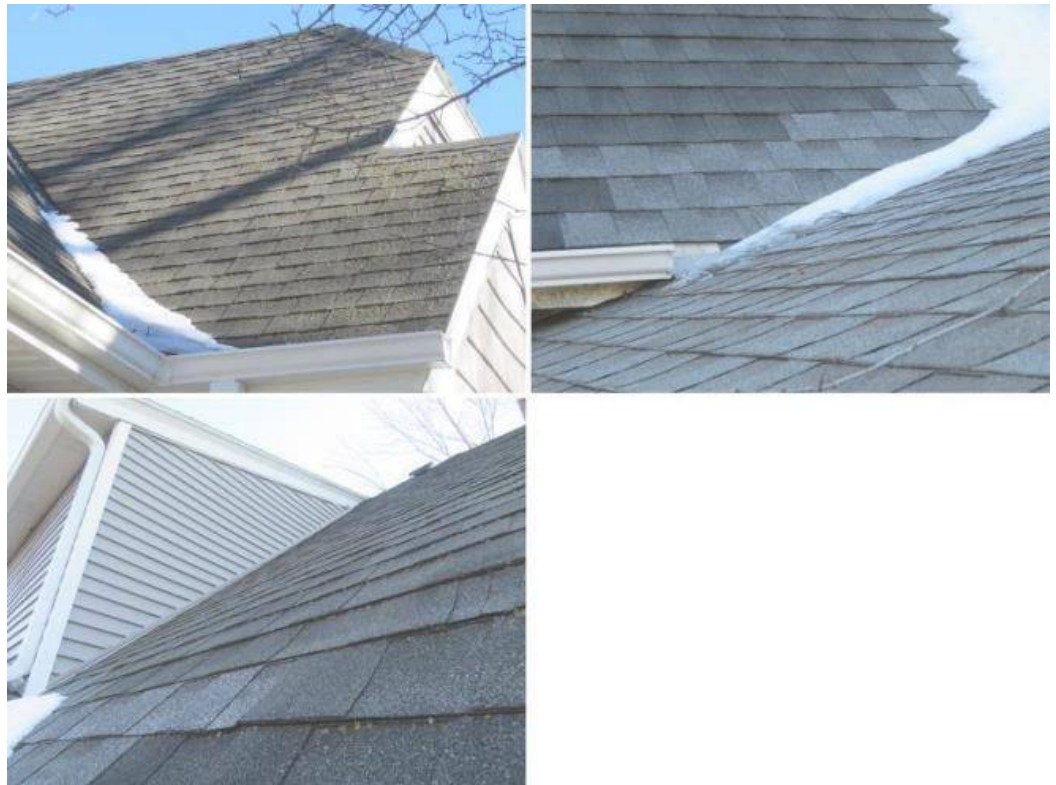
Pitched Roof

Height restricts inspection, Steep slope, Configuration restricts inspection. Lot configuration, Most of the roof was not visible at the time of inspection due to reasons noted. Observations and opinions are limited to visible

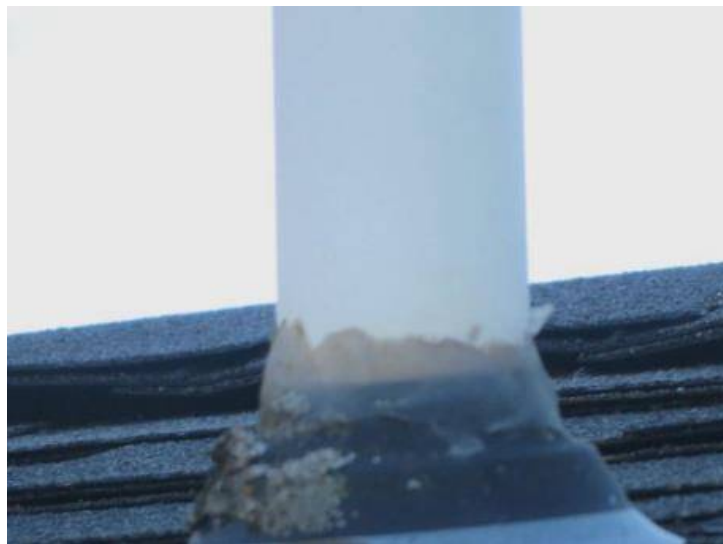
No/restricted access, Lead flashing present. Monitor for holes/cracks/wear. **Synthetic flashing material present. Monitor for holes/cracks/folds/wear at collar. Collar is worn/cracked/torn or has holes/folds/gaps. Needs replacement now. Sealed with roofing mastic/caulk sealant. See note 120 in Reference Addendum. Holes/gaps/cracks. Needs replacement now.**

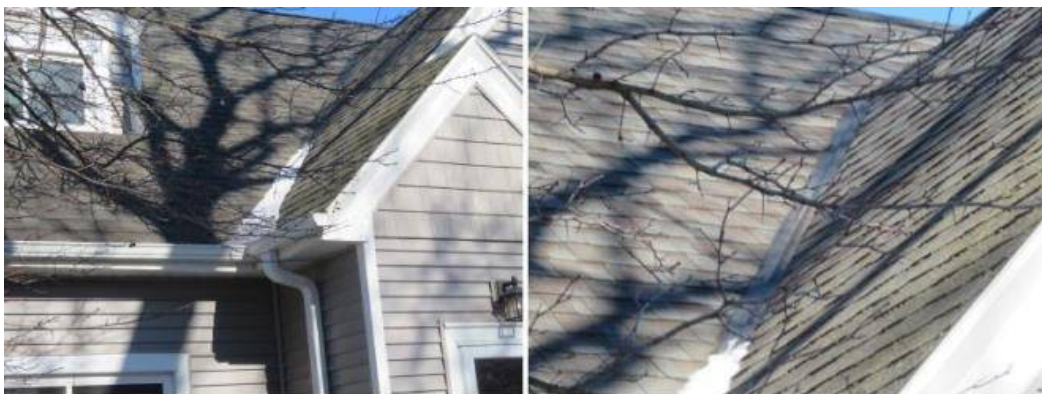
valleys: (4)(a) 2.

No/restricted access, Metal,
Appears functional.

Worn/monitor closely, Ice
chipping (more advanced
wear)

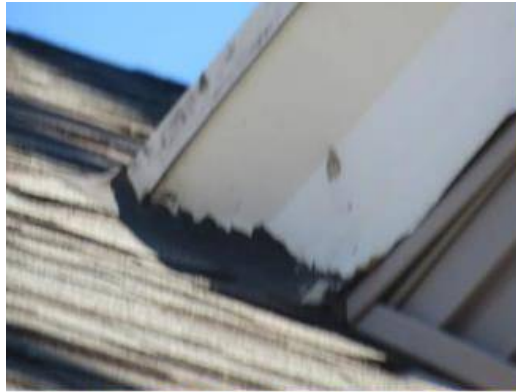
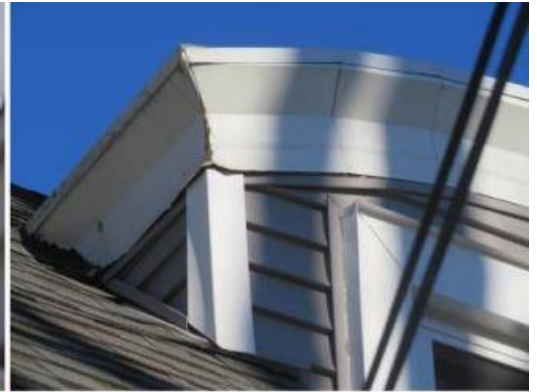
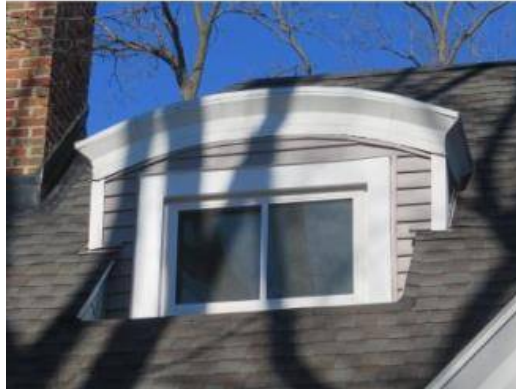
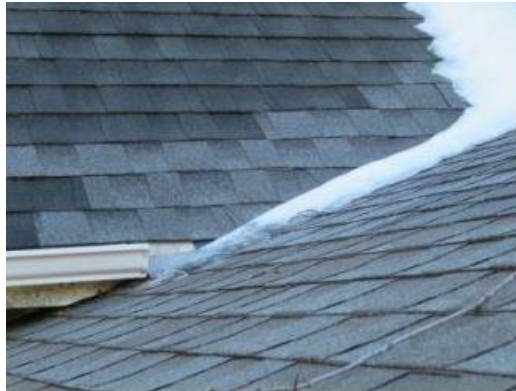
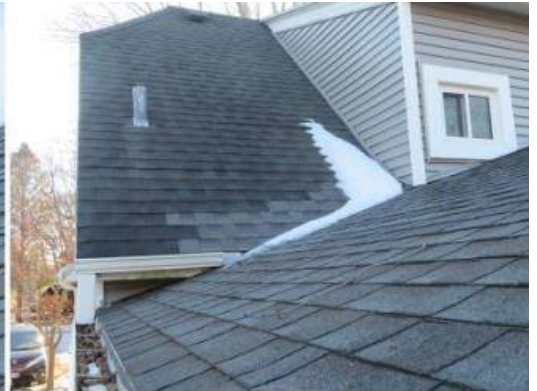
Roof/Wall:

No/restricted access, Water management system not observable. Evidence of prior repairs, Sealed with roofing mastic sealant. See note 121 in Reference Addendum. This restricts inspection of the presence or absence and condition of the flashing at this location. No kick out flashing observed at one or more locations. When the shingles terminate at a wall joint, a kick out flashing behind the siding and on top of the shingles helps direct water into the gutter. Add as prudent. Little clearance between siding and roof. (Recommend a 1" minimum.) This restricts inspection of the presence or absence and condition of the flashing at this location. Multiple locations.

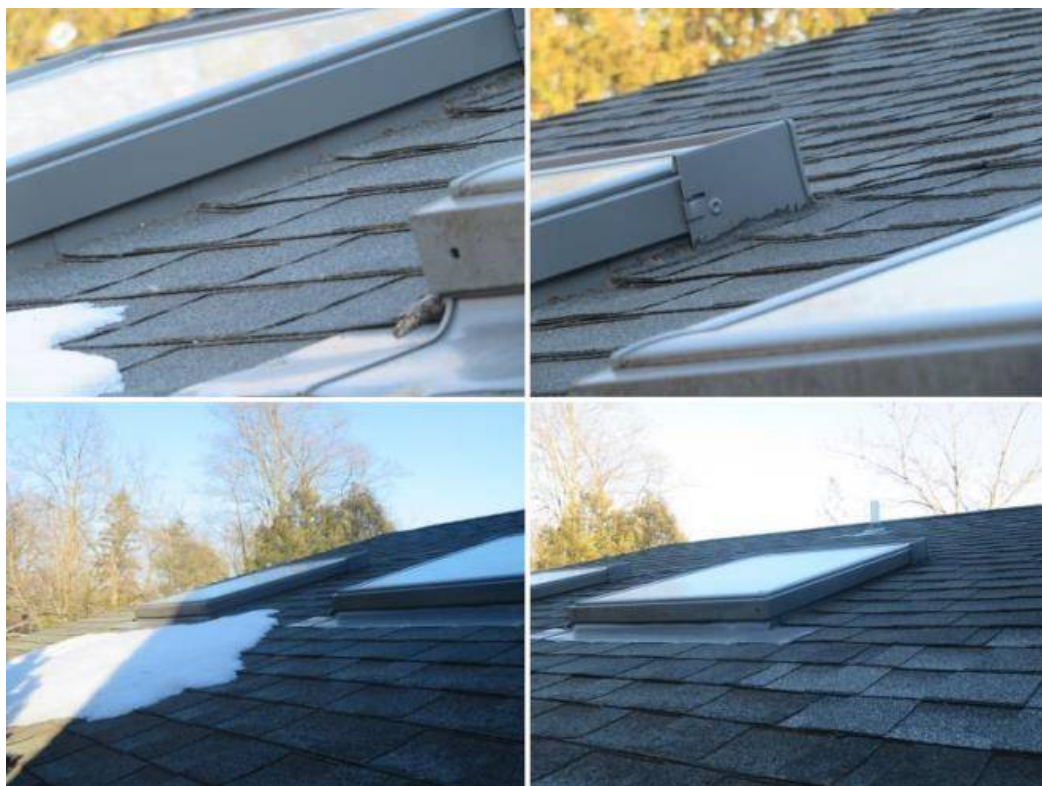
Skylights: (4)(a) 4.

No/restricted access,
Monitor for maintenance
needs, *Skylights typically
have a 20 year life-span.
Suggest replacing upon
re-roof to prevent future
problems.*

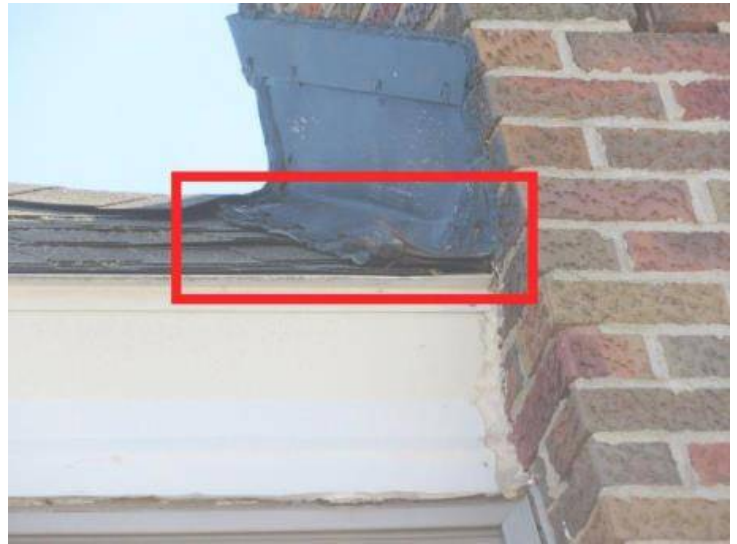
Limited/obstructed view of flashing due to location/access. Chimney flashings are susceptible to leakage at any time. Ask the seller for any history of leaks/water penetration and related concerns. Metal, Roofing mastic/tar sealant. These sealants are temporary and susceptible to leakage at any time. Ask the seller for any history of leaks/water penetration and related concerns, evaluate now, seasonally evaluate, and correct as needed. Counter flashing observed, Flashing installation details, such as whether flashing is cut into brick as a sealed joint and whether there is any corrosion or holes in the flashing, are not visible during visual inspections. Step flashing not visible/verified. Any observations offered are not a warrantee or guarantee that it's not leaking or will never leak. Monitor mastic/caulk sealant annually and repair as needed. See note 121 in Reference Addendum. Ask the seller for any repair or installation documentation and warranty information. Needs caulk/mastic sealant maintenance now. See note 119 in Reference Addendum.

Lifting/pulling away from roof, Heavy caulking/mastic often means there has been water intrusion or other issues. Verify and repair as needed. Temporary mastic/caulk/tar sealant observed. Unconventional/curious materials. Expect water intrusion issues. Flashings unknown/unverified. Evaluate for good installation and common maintenance needs.

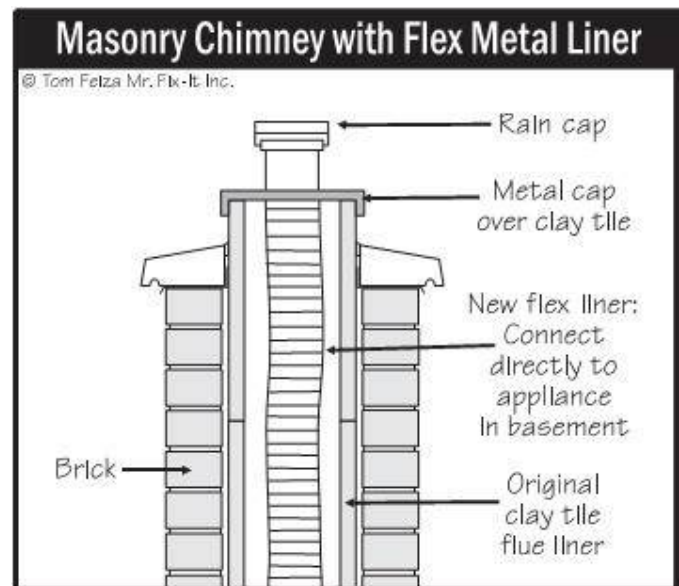
Water heater is venting into an unshared chimney flue with no metal liner. See note 125 in Reference Addendum. The chimney may need a liner. Seek further evaluation by a chimney specialist.

Seek full evaluation of chimney, flues, flashing, and fireplace by a qualified contractor now. The chimney may need a liner. Seek evaluation by a chimney specialist now.

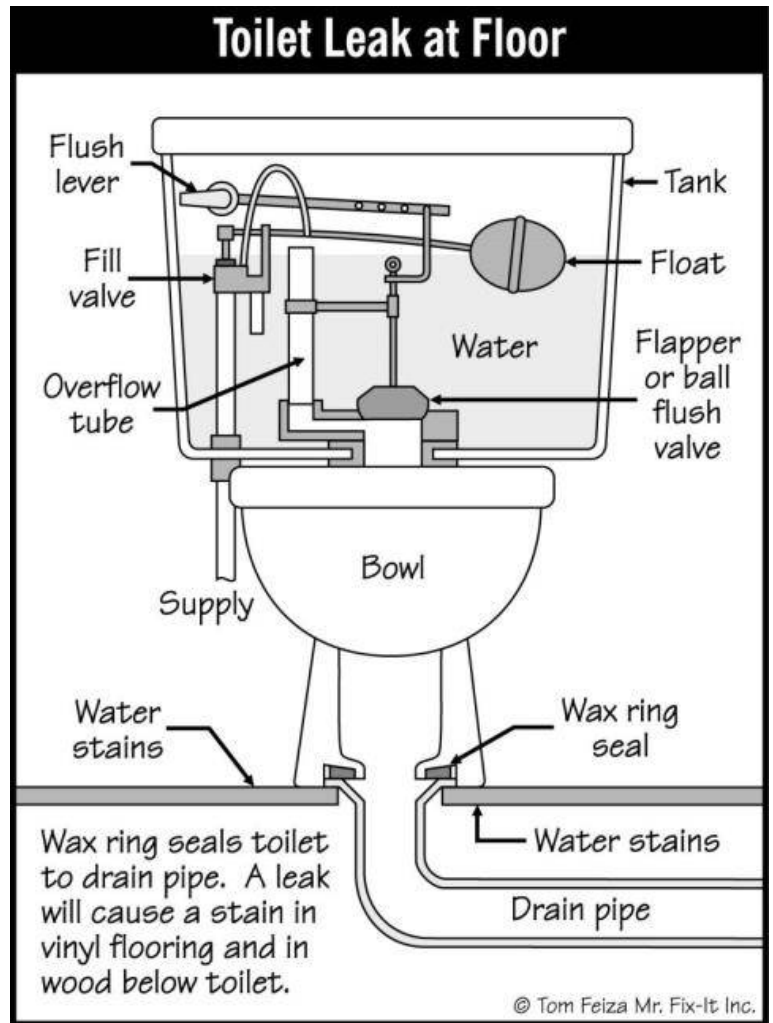
Toilet is loose/not secure at floor. Evaluate all toilets and correct as needed to prevent water seepage issues.

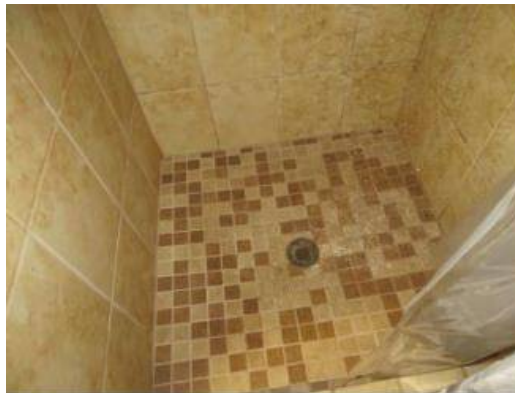
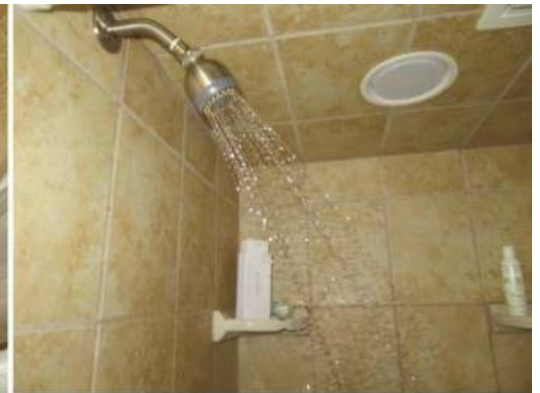
Appears intact, Appears functional, Monitor and maintain pan/enclosure/seams/joints for leakage. Shower pans/drain fittings can leak at any time.

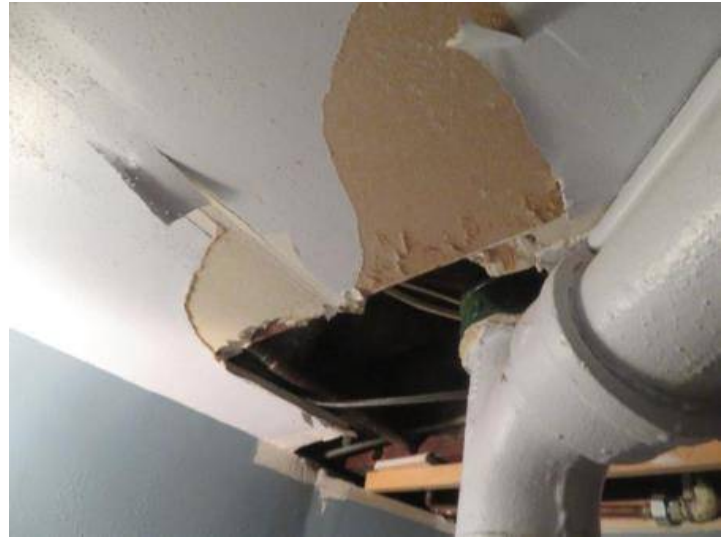
Paint may restrict view of past or present conditions, such as water staining, deterioration, or cracking -see side of basement shower exterior.

Repair ceiling where accessed for a repair above in bathroom, providing access.

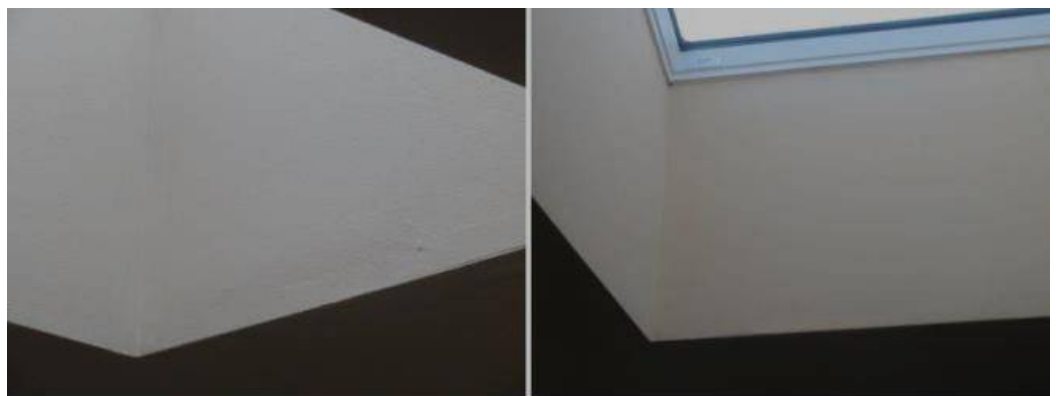
Limited access due to shades/blinds/location. See note 168 in Reference Addendum. Double hung, Casement, Fixed, Skylights, Possible water stains noted at skylight. There was no observable evidence of significant/active leakage at the time of inspection.

Skylights and surrounds are prone to minor staining due to humidity/condensation. Evaluate skylight window systems for condensation/leak issues and for good function now. Repair as needed. Worn finishes Appear intact, Appear functional, Obtain any possible warranty documentation for modern windows. Water stains on/at windows. Source not determined (possible condensation, over-watering of plants, open windows during rain and wind, etc.).

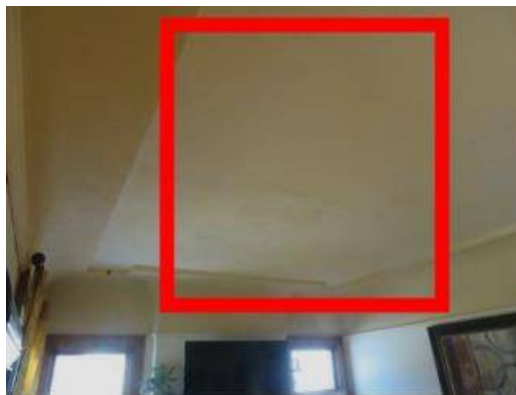
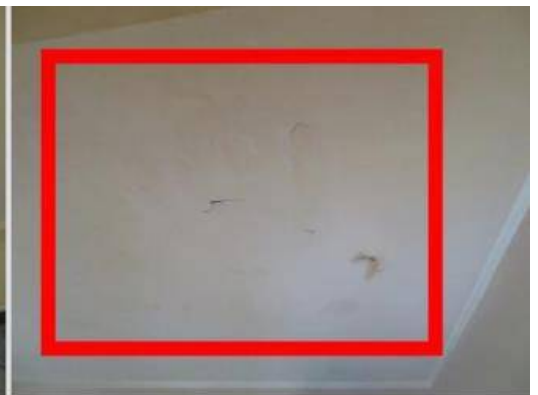
Ceiling and wall framing are not observable due to finishes/insulation. Appears functional, Typical for age, Common fractures, Evidence of possible history of leakage/ condensation issues observed. Staining/lifting surfaces/discoloration observed, Blistering/lifting of paint at surfaces is evidence of possible history of leakage or humidity. Area tested dry with moisture meter at the time of inspection. Any water

stains and damp materials should be investigated for extent of water intrusion issues and repaired as needed. Correct source. Ask owner for history and cause of staining. Patching.

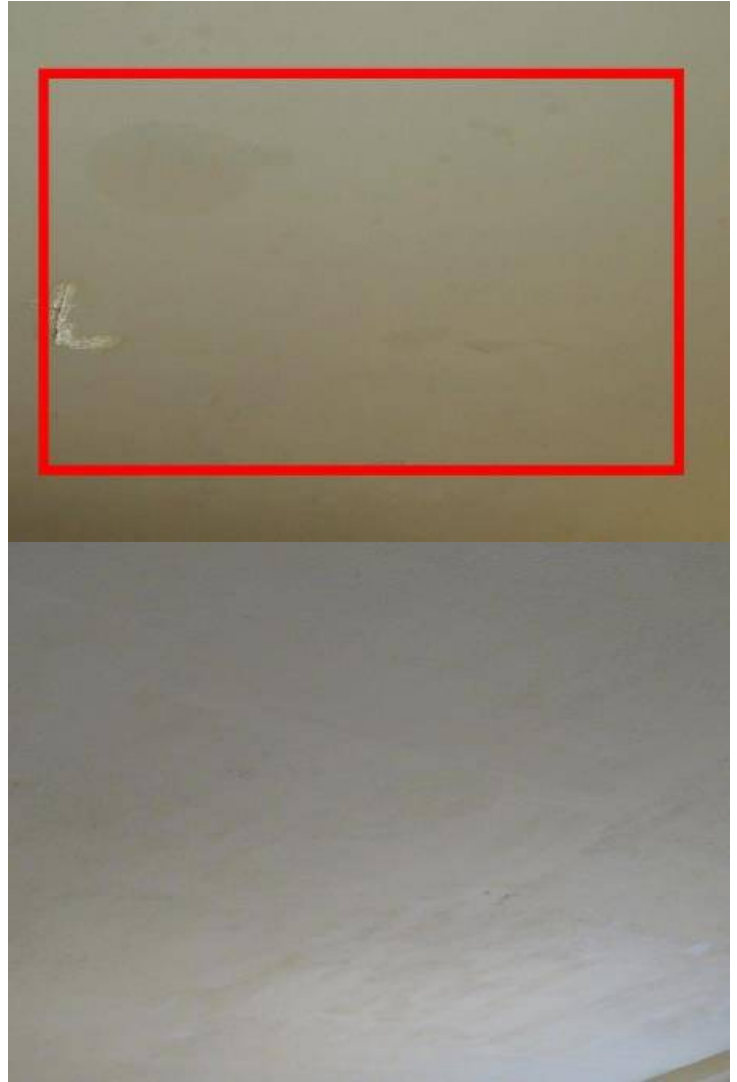
Front upper bedroom SW at eyebrow dormer west side and Front living room ceiling and skylight coffer surrounds: Typical nail pops, Evidence of possible history of leakage observed. Apparent patching/repaired finishes noted at ceiling/wall. Evidence of possible prior ice damming observed. Area tested dry with moisture meter at the time of inspection. Any water stains and damp materials should be investigated for extent of water intrusion issues and repaired as needed. Correct source. Uneven surface, Patching, Discoloration observed is evidence of a history of excess humidity/condensation or water intrusion. If this is a concern, consider further evaluation by a qualified specialist.

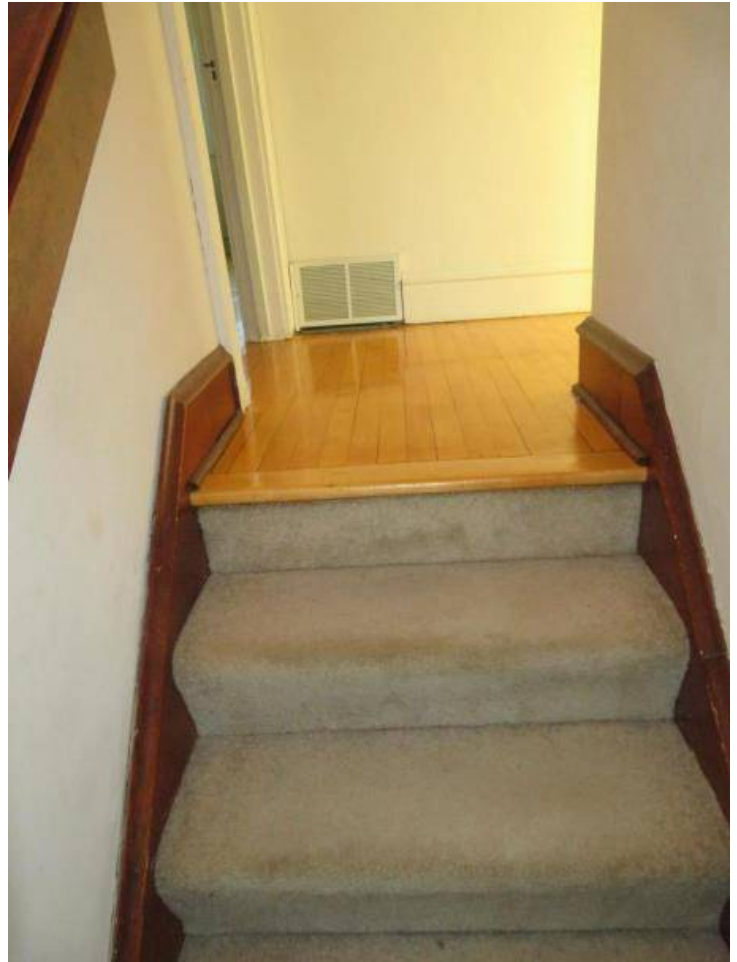
Appears intact, Appears functional, Missing railing where there are four or more steps. Railing(s) not graspable. Add a graspable railing.

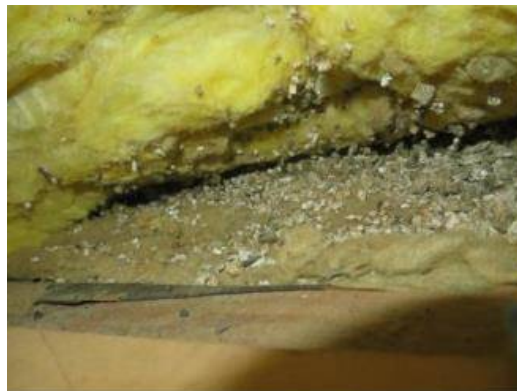
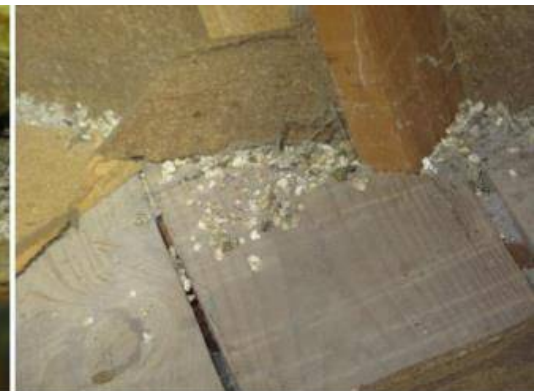
Fiberglass, Vermiculite. This type of insulation is associated with asbestos material. Consult an indoor air quality specialist for information and recommendations about this material. See <http://www.zonoliteatticinsulation.com/> for more information.

Vermiculite. This type of insulation is associated with asbestos material. Consult an indoor air quality specialist for information and recommendations about this material. See

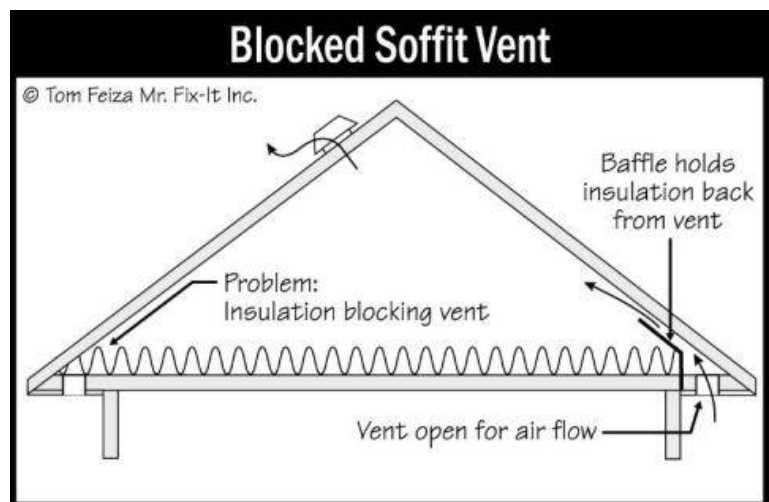
Minimal ventilation. Contact Wisconsin's Focus on Energy Program for a Building BPI Certified Analyst to determine attic ventilation/insulation needs and design recommendations. See <https://focusonenergy.com/> for more information. No view of soffit vents/air baffles. Correct as needed. Minimal/no soffit venting. Correct as needed.

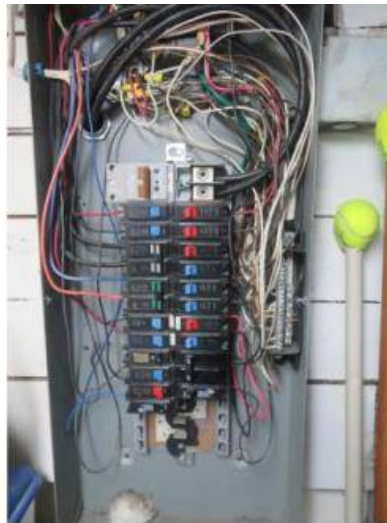
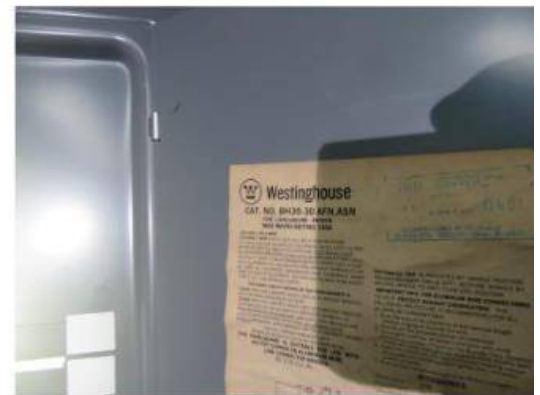
Appears functional, Appears neat and orderly. Mixed brands of breakers suggest possible unconventional installation, May contain used components. Improper clearance. There should be a clearance of at least 36" to the front and sides of the main panel.

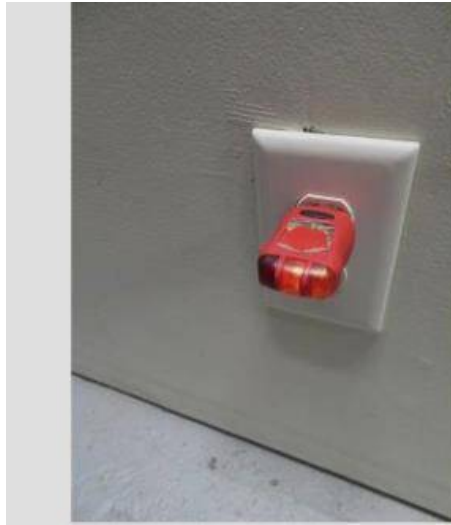
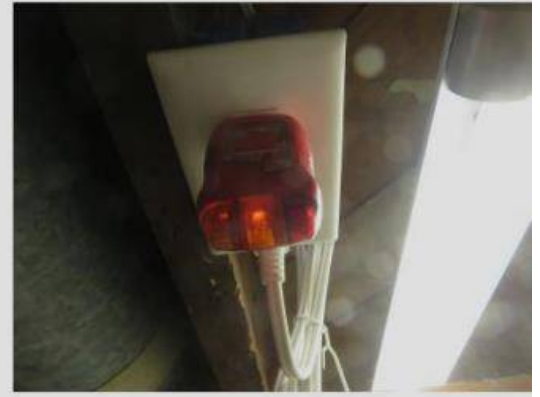
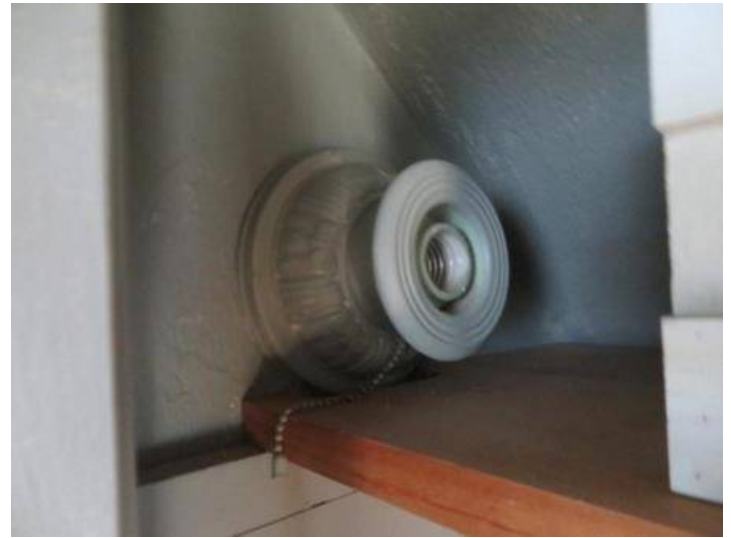
Finishes restrict inspection of branch circuits. Inspection is limited to a representative number of outlets, switches, and lights per state standards. Open ground outlet(s). Unable to view wires inside wall to determine wire type or cause of open ground. Verify that there is no old wiring without a ground (such as knob and tube) now as prudent. Basement.

Correct items noted by licensed electrician. Modern/recent electrical service installation. Verify whether there is any service warranty offered.

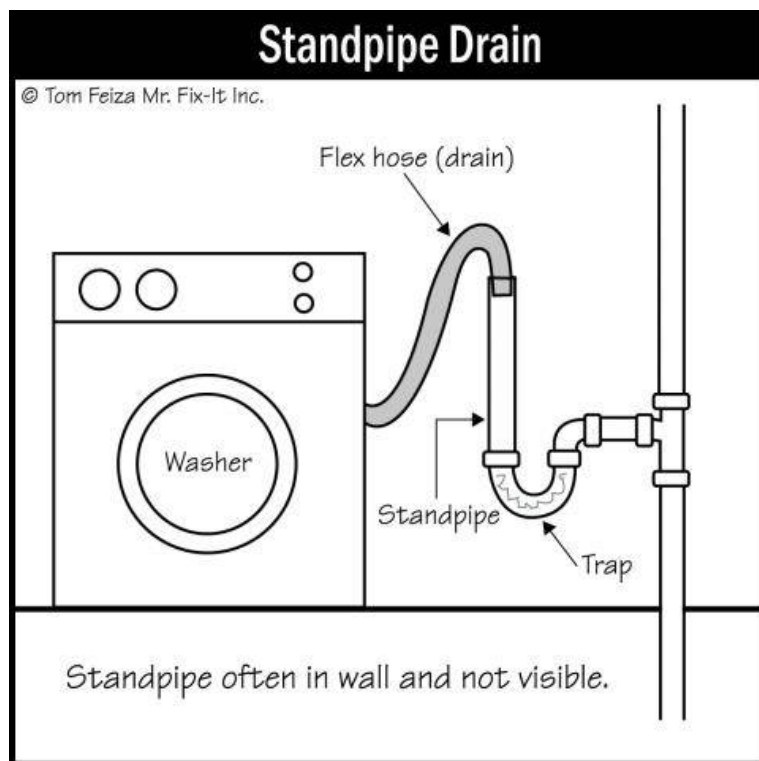
Small pliable hose drains directly into sewer drain pipe with no trap or air gap. Correct to avoid methane and facial particles going in drain hose and to appliance source.

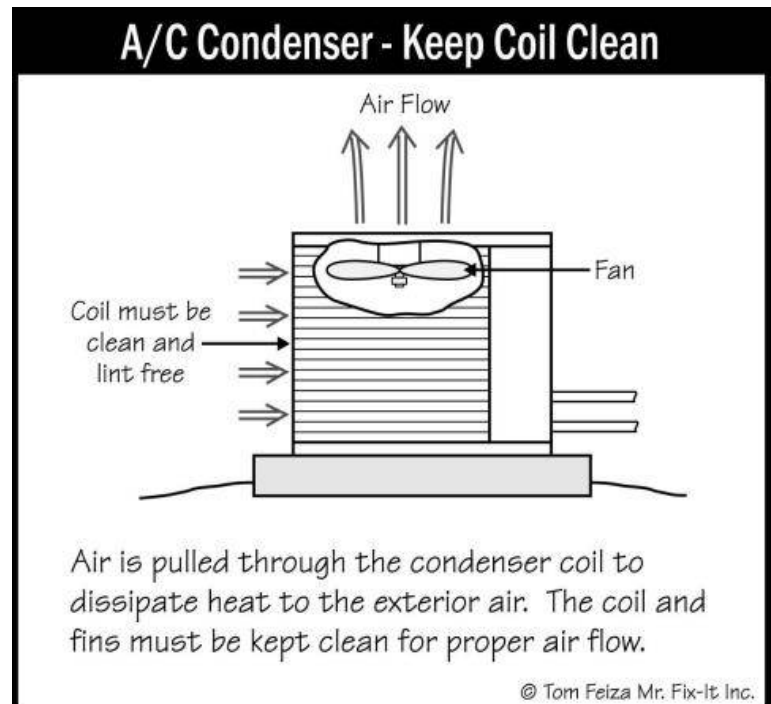
Appears functional, Dirty fins/coils. This reduces efficiency and can even damage the unit if air flow is significantly restricted.
