Ms. Marylin Friend  
2020 N. Longview Ave., Brookfield, WI.  
06/01/2017

Scot W. McLean, ASHI  
333 W. Brown Deer Rd. #117, Bayside, WI 53217  
Phone: 414-228-6573  
<http://www.tandcinspection.com>

# Report Index

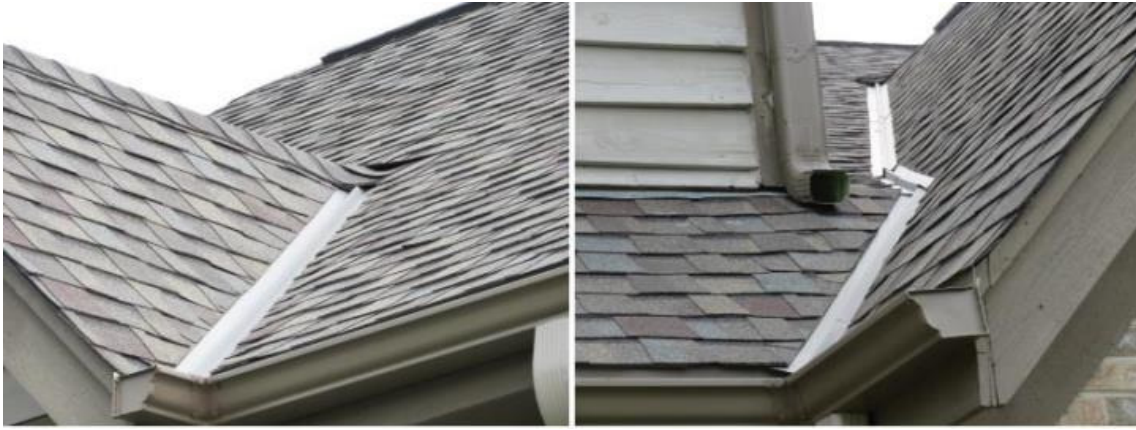
### Valley:

Metal, Appears functional.

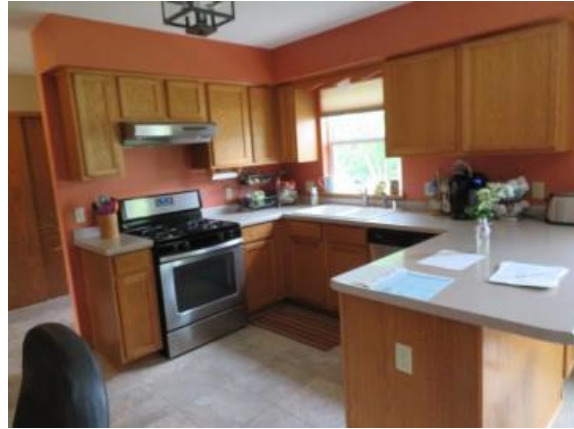
One main kitchen.

Restricted view below sink.

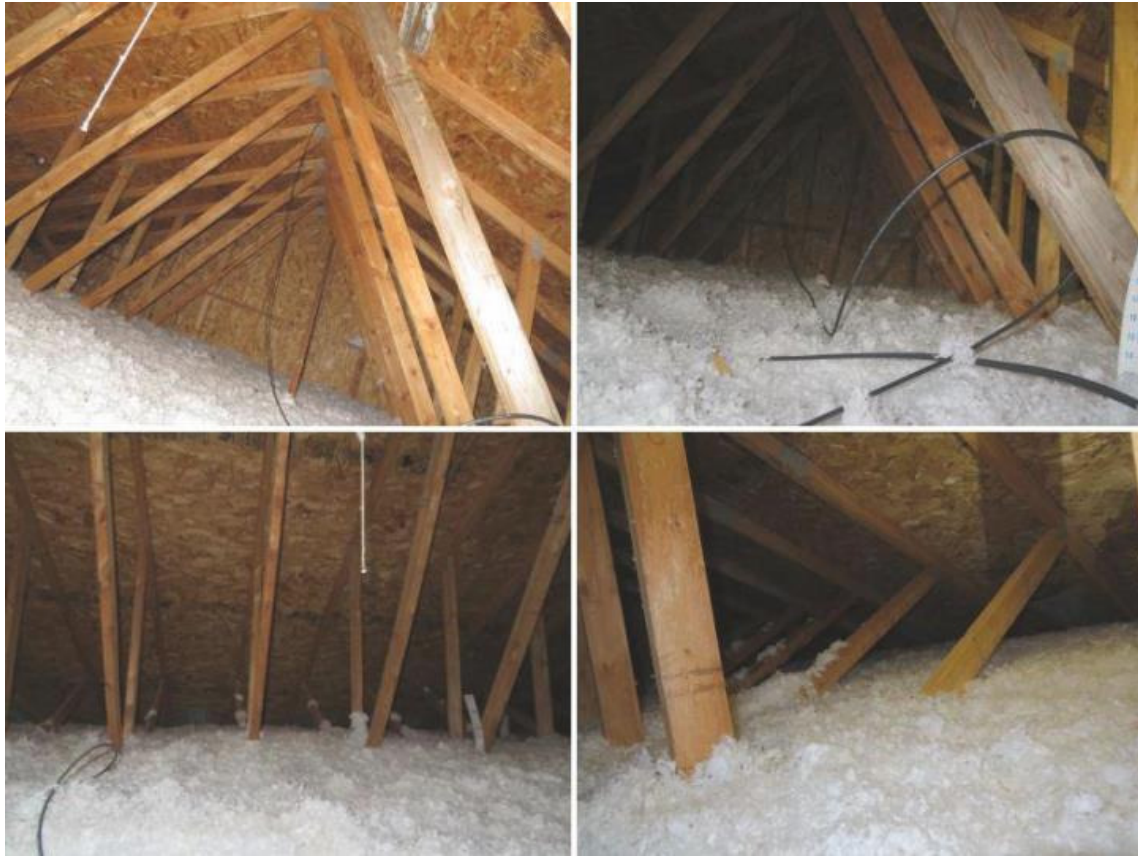
Ceiling access hatch: Viewed from hatch, Wall access door/hatch: Viewed from hatch.

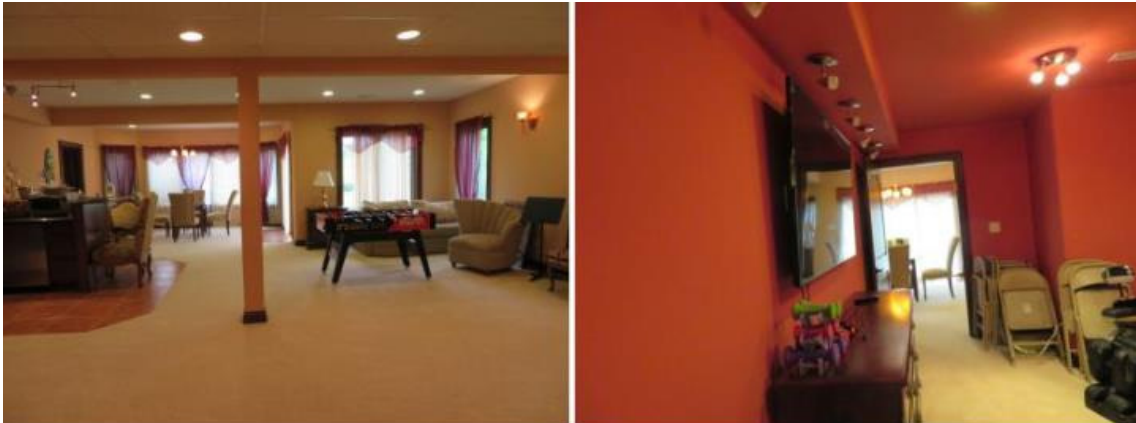
Walls:

Storage/shelving/equipment/appliances limited inspection: 30% to 40%. Finished foundation walls: 60% to 70%. Painted foundation walls (modern): 80% to 90%.

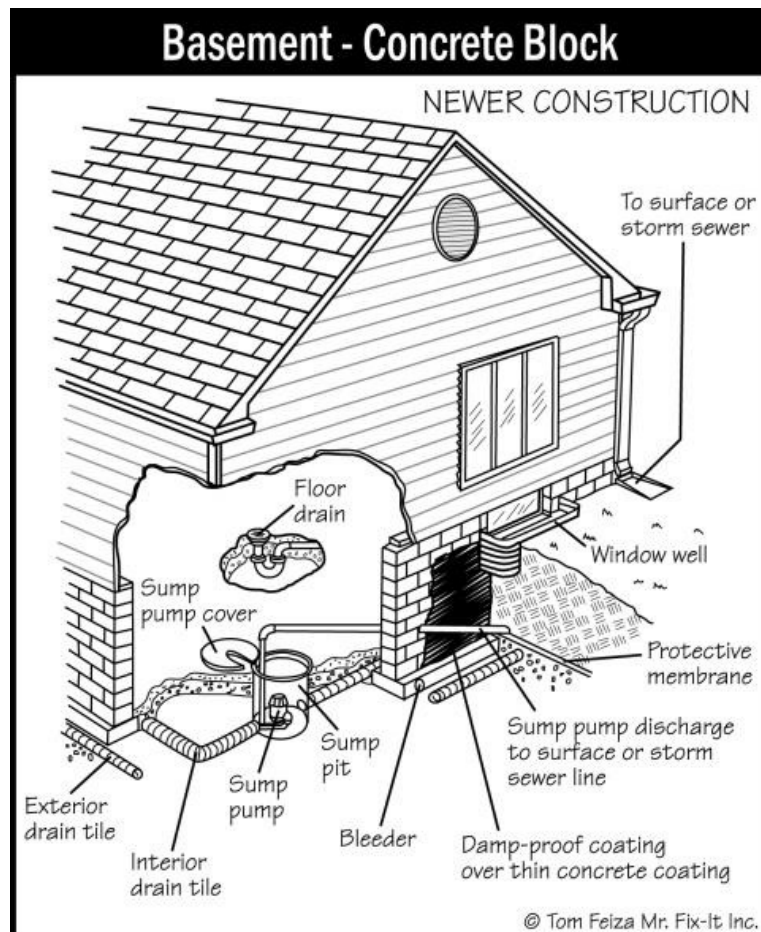
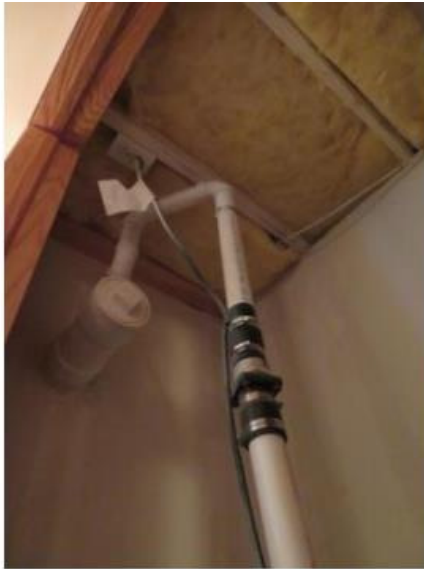
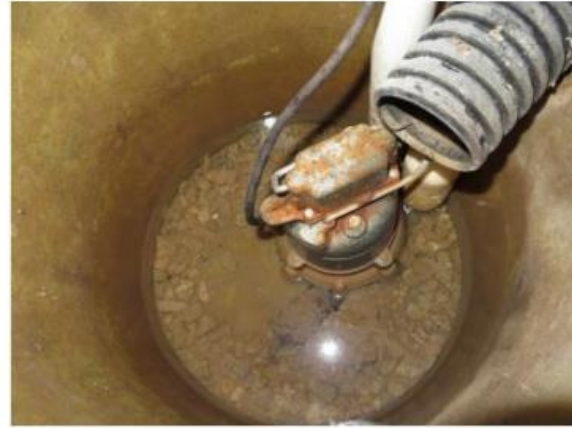
B005

See note 138 in Reference Addendum. Radon system present. Radon systems are beyond the scope of a Home Inspection. EPA guidelines require testing for accurate function every two years. Ask seller for history. Consult [lowradon.org](http://lowradon.org) for more information. Battery back up not tested. See manufacturer's instructions for how to verify good function and perform regular maintenance. Batteries generally last two years.

Footings and drain tiles are not visible for inspection. See note 136 in Reference Addendum.

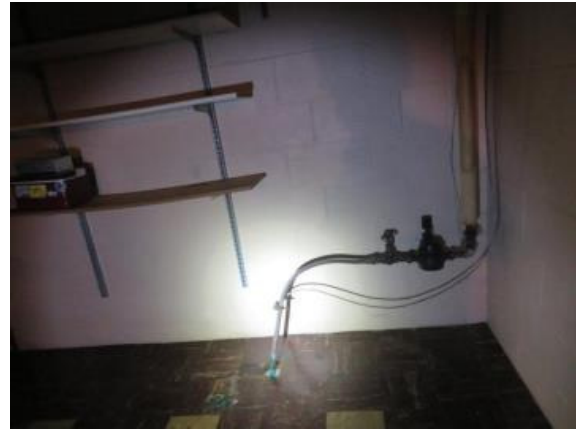
Appears intact, Older/worn valves, Monitor for leaks and good function.

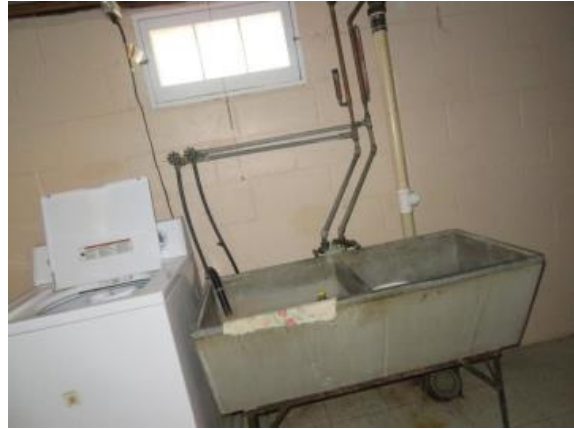
Laundry room, First floor.

Washing machine discharges into a drain in the wall. Not tested. Inspection is limited to visible areas only.

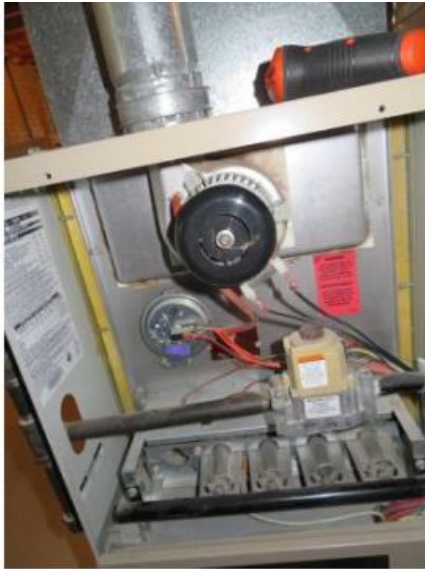
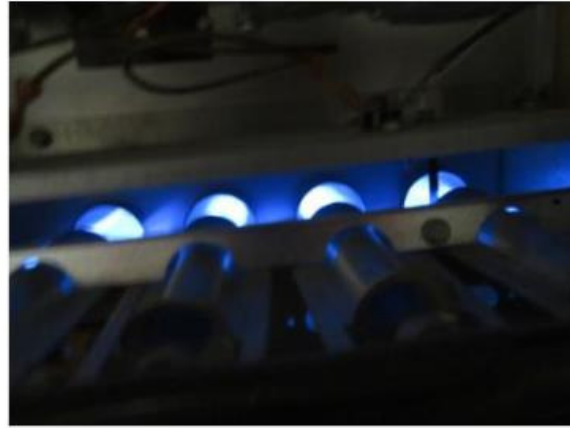
Operated when tested, No recent maintenance record found. This suggests that the furnace may be due for a seasonal tune and clean. Suggest asking seller for any service records not posted at the unit. Well maintained, Poorly maintained.

Recommend seasonal tune up and safety equipment check of all HVAC equipment by a qualified specialist.

Recommend professional service annually as regular tune ups help to prolong the unit's life expectancy and support safe and reliable function.
