Mr. Buyer
2030 Martin Dr. Milwaukee, WI.
01/21/2022

Scot W. McLean, ASHI
333 W. Brown Deer Rd. #117, Bayside, WI 53217
Phone: 414-228-6573
<http://www.tandcinspection.com>

Inspection Summary

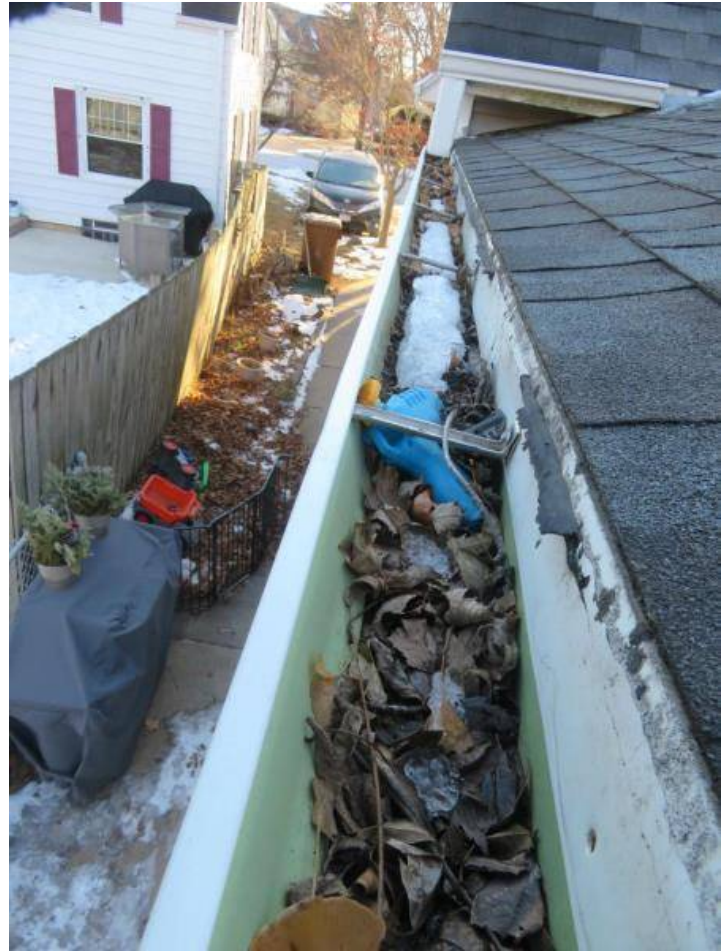
Height restricts view, Metal, Evidence of possible ice damming. Monitor for leakage and ice damming. If ice damming occurs in the future, seek further evaluation by an Energy Auditor. Evidence of a history of gutter overflow conditions/drip line noted. This may be due to improper slope or debris in gutters or downspouts. Repair and improve function, and keep water off structure and foundation areas. No kick out flashing observed at one or more locations. When the shingles terminate at a wall joint, a kick out flashing behind the siding and on top of the shingles helps direct water into the gutter. Add as prudent. Monitor for overflow conditions/leakage and maintain/correct as needed for good function. Trees nearby. Gutters will require frequent cleaning. Monitor for overflowing and clean as necessary. Add gutters where missing to protect the building, foundation, and structure as prudent. Need cleaning/maintenance. Clogged gutters/downspouts do not functional as designed.

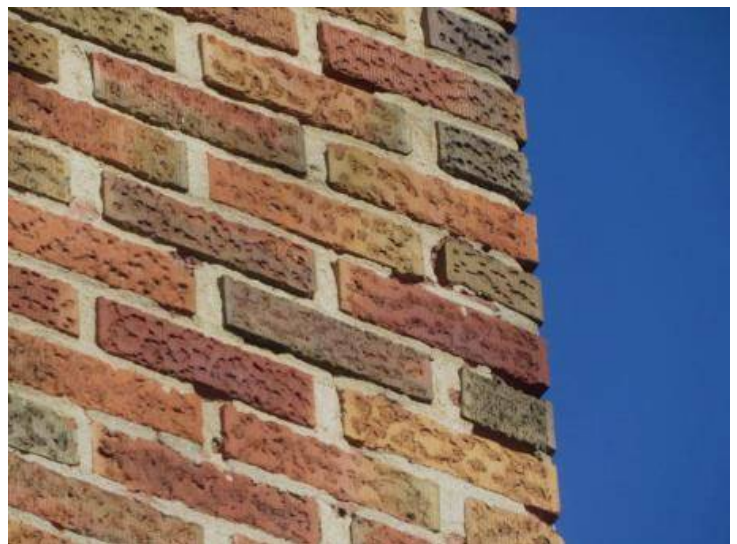
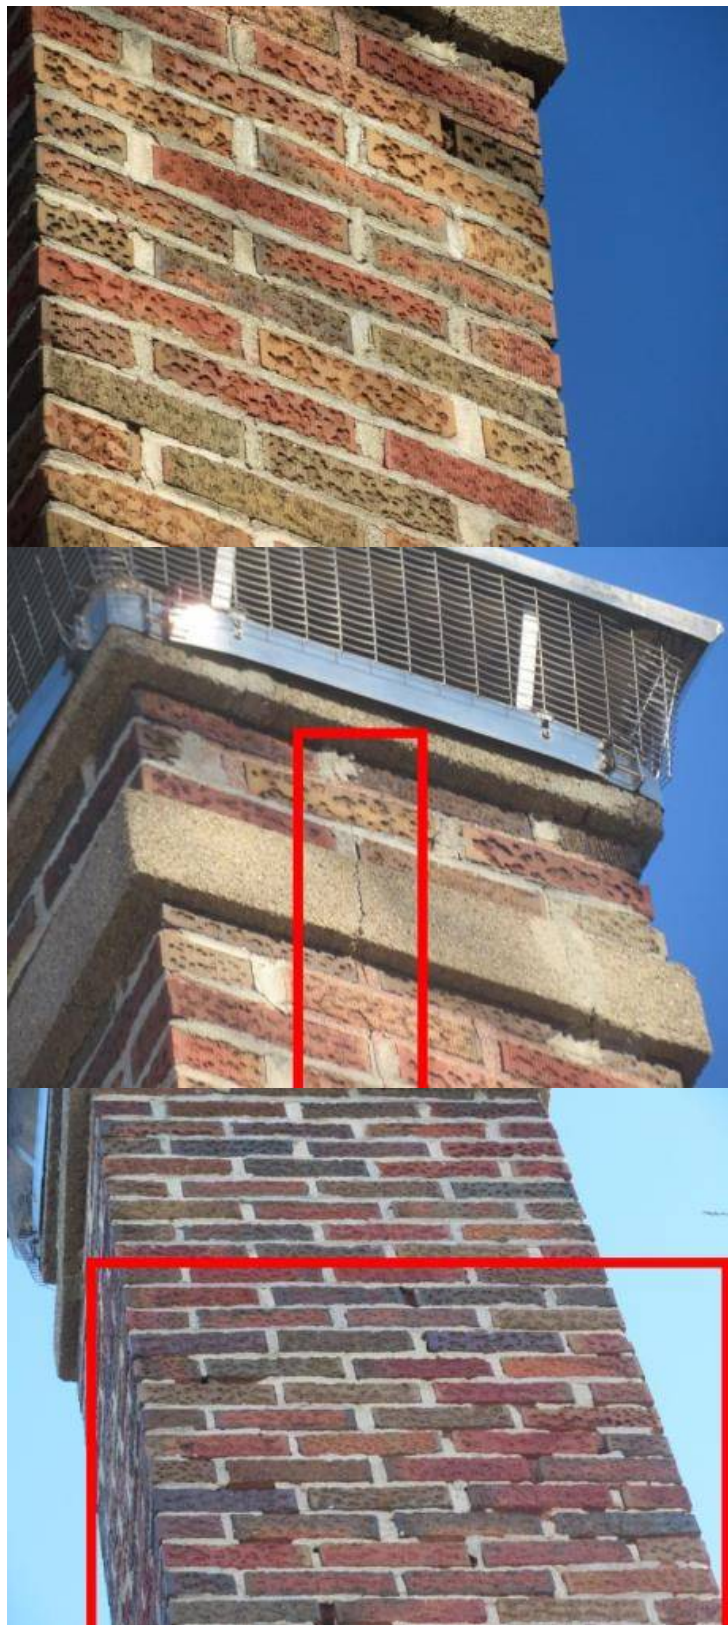
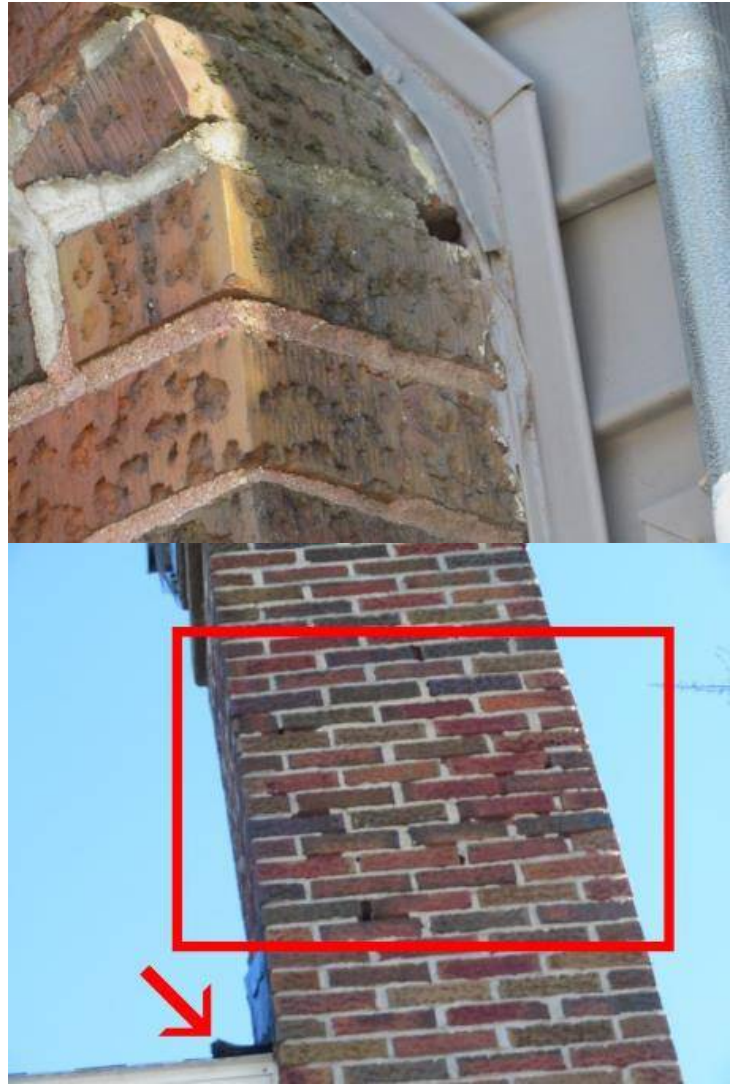
Flakes/chips/debris noted in fireplace indicate deterioration of tile chimney liner. This may indicate either a history of repairs or a potential need for repairs. Ask the seller for any history of recent repairs. Seek a NFPA Level Two Evaluation (with camera scope) by a trained and NFPA certified fireplace specialist as needed now. A level 2 chimney inspection is conducted by running a specialized inspection camera through the interior of the fireplace and chimney to inspect for concealed damage to the flue liner, as well as the inspection of the exterior of the chimney, fireplace(s), chimney system(s), attic spacing and condition, flashings, and flue(s).

One main chimney, Front, Multiple flues located in one chimney structure.

We suggest having the chimney specialist check the chimney system after it has been swept. Seek further inspection of fireplace(s), chimney system(s), flashings, and flue(s) now by a qualified chimney specialist. We recommend a CFI Certified level II camera scope evaluation.

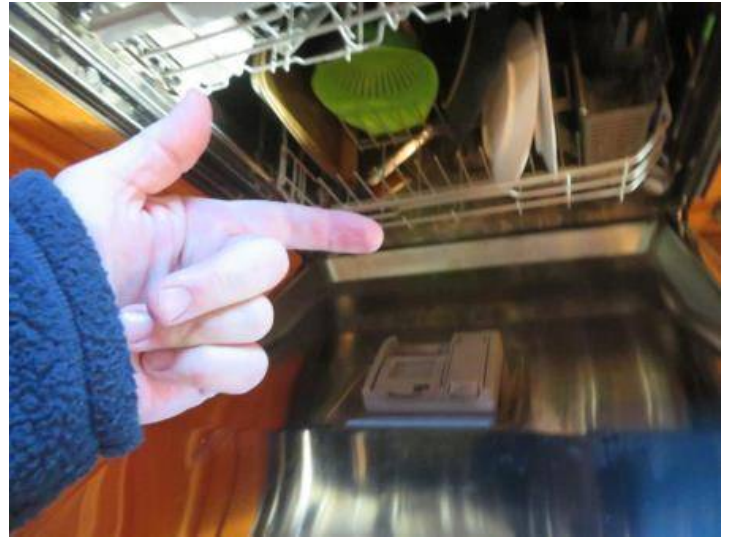
Dishwasher cycled at the time of inspection. See note 127 in Reference Addendum. **Dishwasher not secured at bottom. Suggest properly installing dishwasher.**

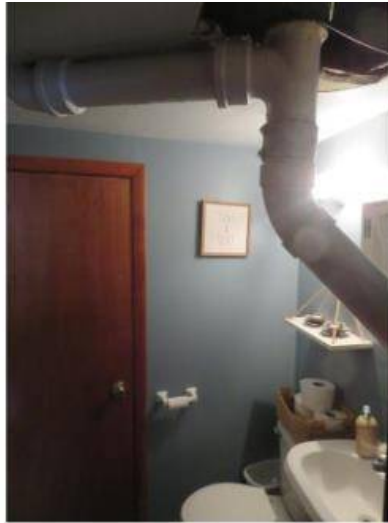
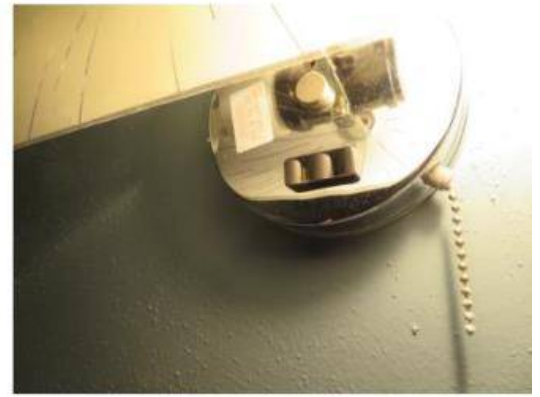
No ventilation present in bathroom. No exhaust fan present in bathroom. We suggest adding an exhaust fan. Separate area shower location- Fan: Verify that fan installed in the shower enclosure is designed for shower installations. Curious installation of exhaust fan. Recommend confirming that all exhaust ventilation is connected without holes or gaps all the way to exterior of building.

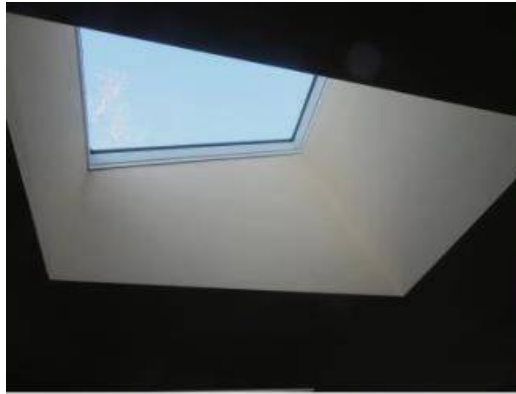
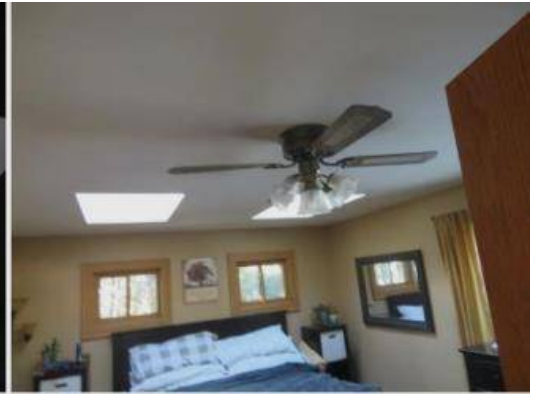
Ceiling and wall framing are not observable due to finishes/insulation. Appears functional, Typical for age, Common fractures, Evidence of possible history of leakage/ condensation issues observed. Staining/lifting surfaces/discoloration observed, Blistering/lifting of paint at surfaces is evidence of possible history of leakage or humidity. Area tested dry with moisture meter at the time of inspection. Any water

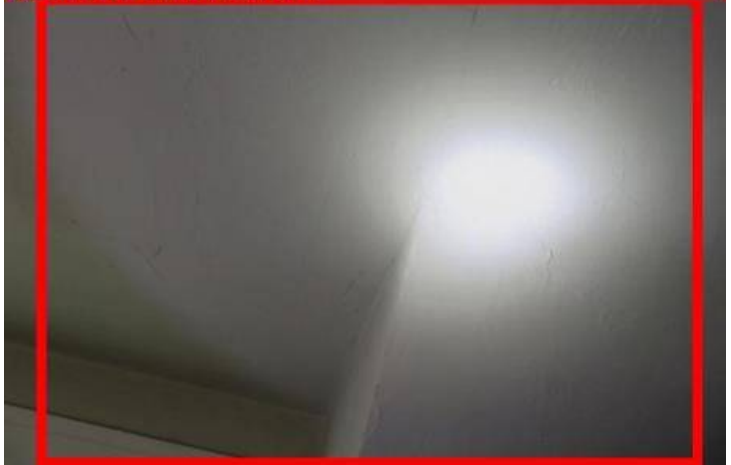
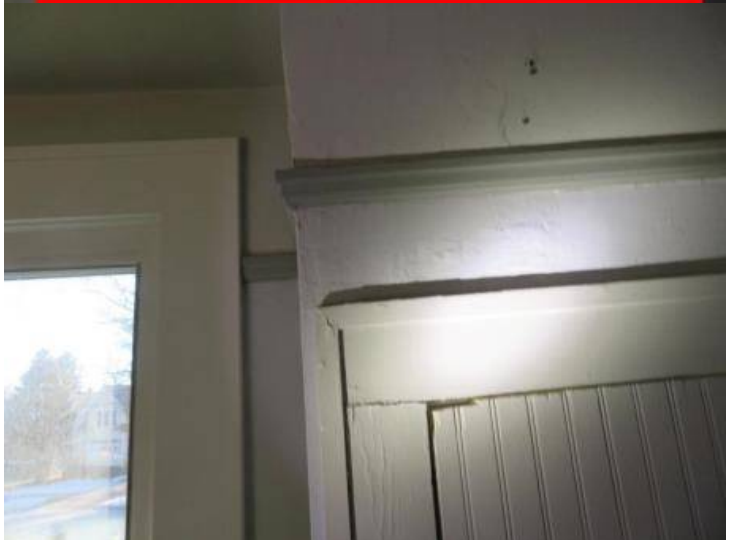
Front upper bedroom SW at eyebrow dormer west side.

Front upper bedroom SW at eyebrow dormer west side and Front living room ceiling and skylight coffer surrounds: Typical nail pops, Evidence of possible history of leakage observed. Apparent patching/repaired finishes noted at ceiling/wall. Evidence of possible prior ice damming observed. Area tested dry with moisture meter at the time of inspection. Any water stains and damp materials should be investigated for extent of water intrusion issues and repaired as needed. Correct source. Uneven surface, Patching, Discoloration observed is evidence of a history of excess humidity/condensation or water intrusion. If this is a concern, consider further evaluation by a qualified specialist.

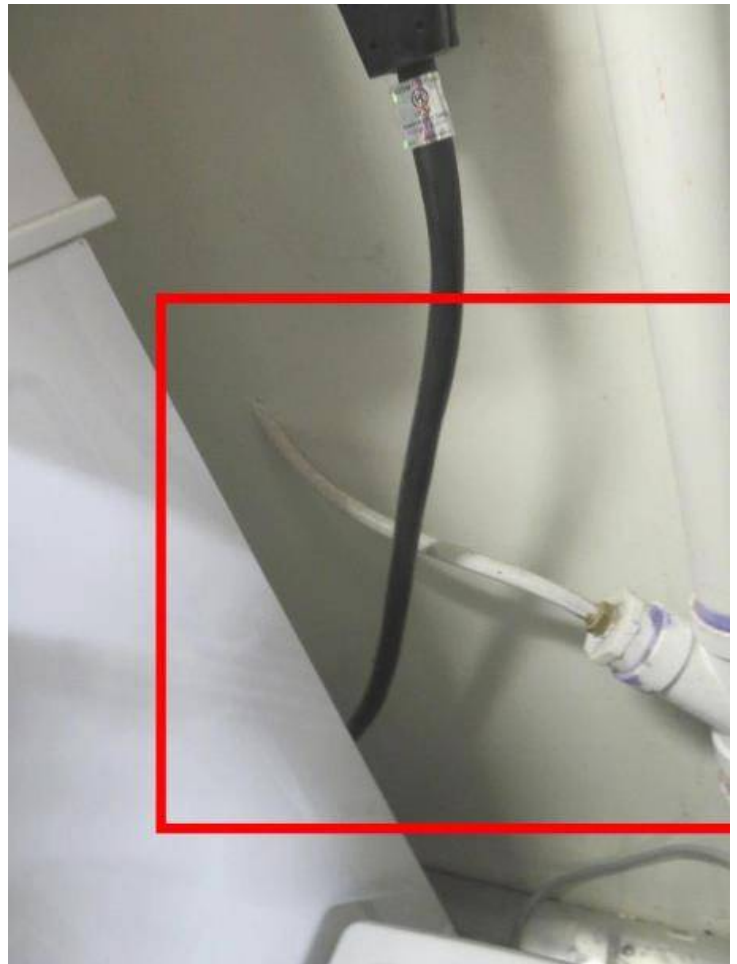
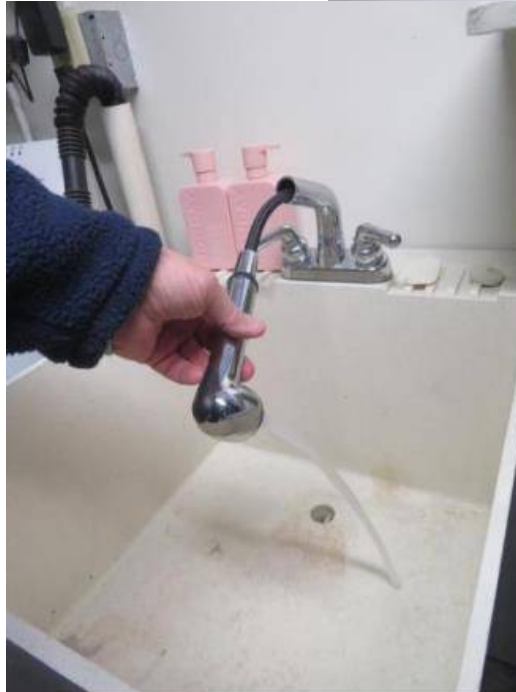
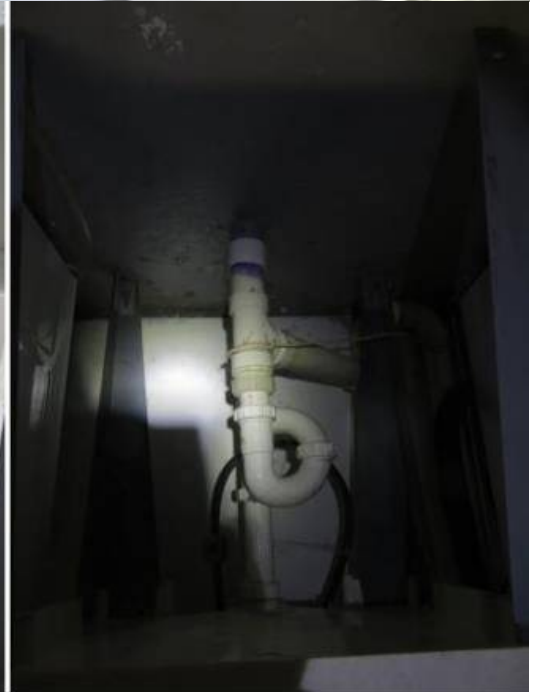
Plastic sink/tub, Sink appears to function properly, Improper trap/vent, Prior repairs noted. No venting observed, verify as needed.

Small pliable hose drains directly into sewer drain pipe with no trap or air gap. Correct to avoid methane and facial particles going in drain hose and to appliance source.

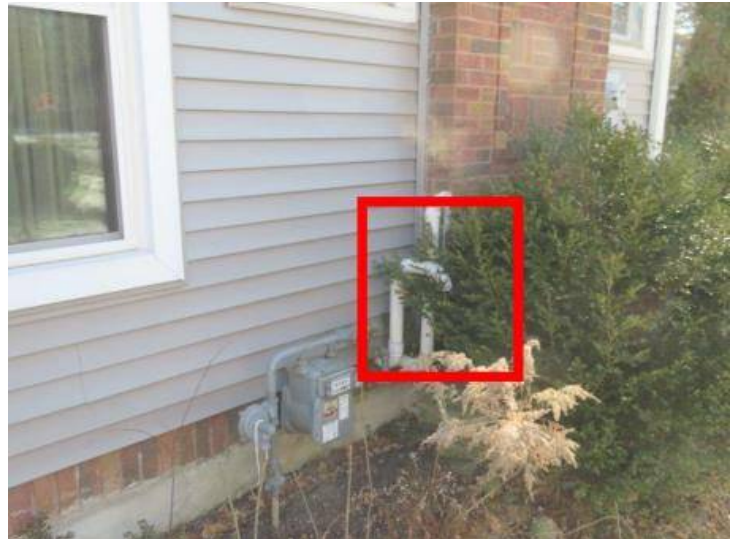
Flue Pipe: (g)(a) 4.

PVC. Appears functional.

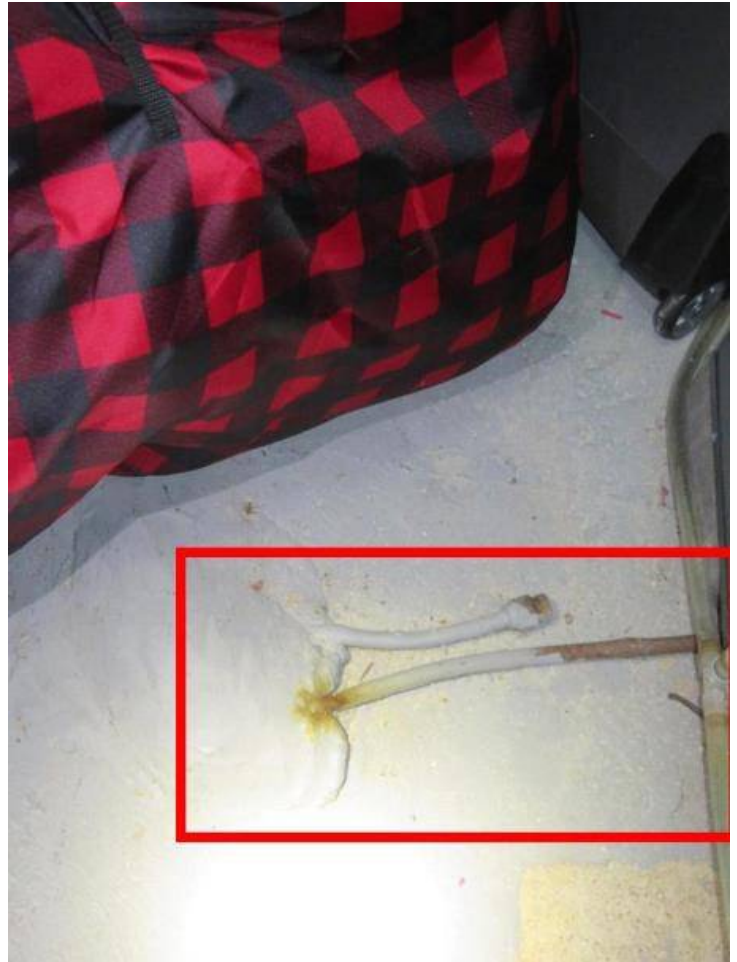
Fuel Tank: (g)(a) 4.

There is evidence that an underground fuel storage tank was or may be present. Verify satisfaction of permit for removal. More information MAY be available at

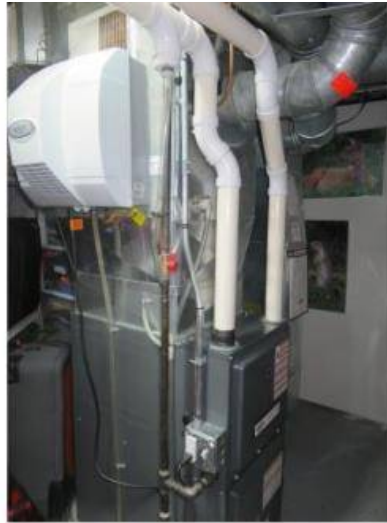
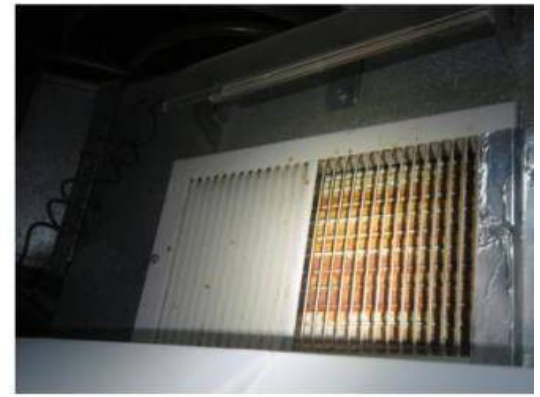
System Condition:

Operated when tested, Well maintained, Durable construction.

Recommend seasonal tune up and safety equipment check of all HVAC equipment now by a qualified specialist. Maintain unit per manufacturer's specifications in order to retain warranty.

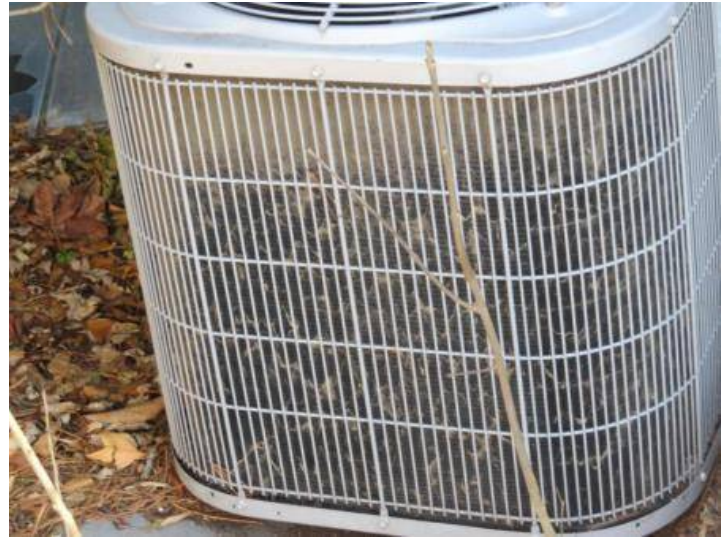
A014

Appears functional, Dirty fins/coils. This reduces efficiency and can even damage the unit if air flow is significantly restricted.

Not tested. Recommend seasonal tune up and safety equipment check of all HVAC equipment now by a qualified specialist. Maintain unit per manufacturer's specifications in order to retain warranty. Air conditioning unit uses older refrigerant, and it is not practical to switch to a different refrigerant. R-22 refrigerant may be unobtainable for repairs/recharging, so unit will likely need to be replaced if refrigerant gets/is low.
